**REPORT ON INDEPENDENT  
ANALYSIS AND ADVICE  
REGARDING THE SAFETY CASE  
ADDENDUM**

**FINAL VERSION**

**Doel 3**  
**Reactor Pressure Vessel  
Assessment**

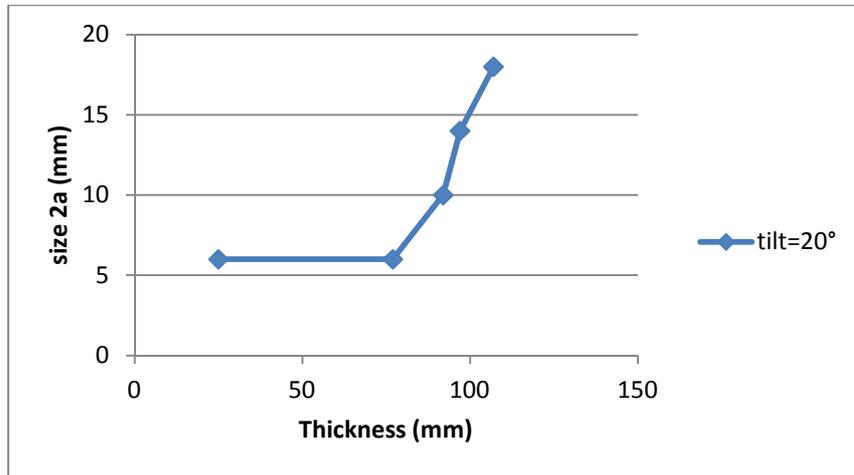
**Figure 2.1: Size of the largest flaws with 20° inclination potentially not reported by UT inspection**

The Safety Authorities requested the performance of a sensitivity study of mechanical integrity. An envelope curve for the size of a potentially unreported flaw was determined in order to obtain a realistic basis to add potentially unreported flaws. Based on that input, the Project Team simulated various flaw configurations (orientation, size, tilt). The curve below represents the maximum size of a potentially unreported flaw with a conservative 20° tilt. This is the main input for the sensitivity analyses (see Chapter 5.3).

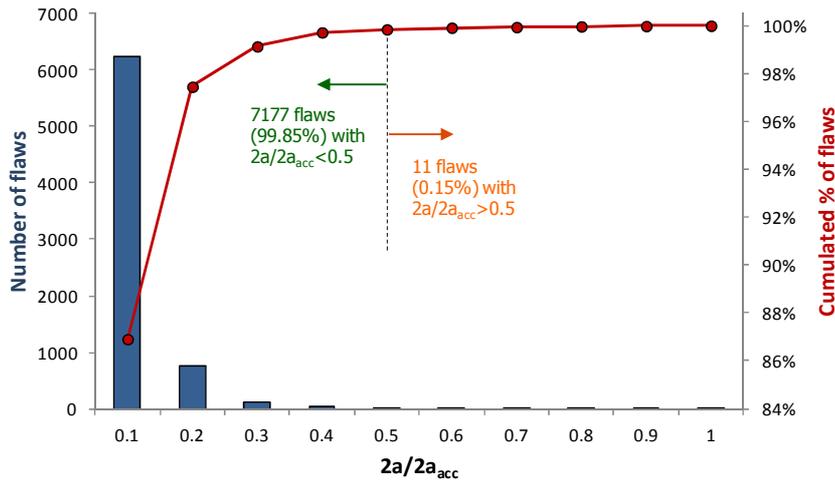
Figure 5.1: Flaw-screening criterion applied to core shells of Doel 3

Applying the flaw-screening criterion to the flaws detected in the RPV core shells of Doel 3 shows that eleven flaws (isolated or grouped) exceed the flaw-screening criterion, as illustrated in Figure 5.1:

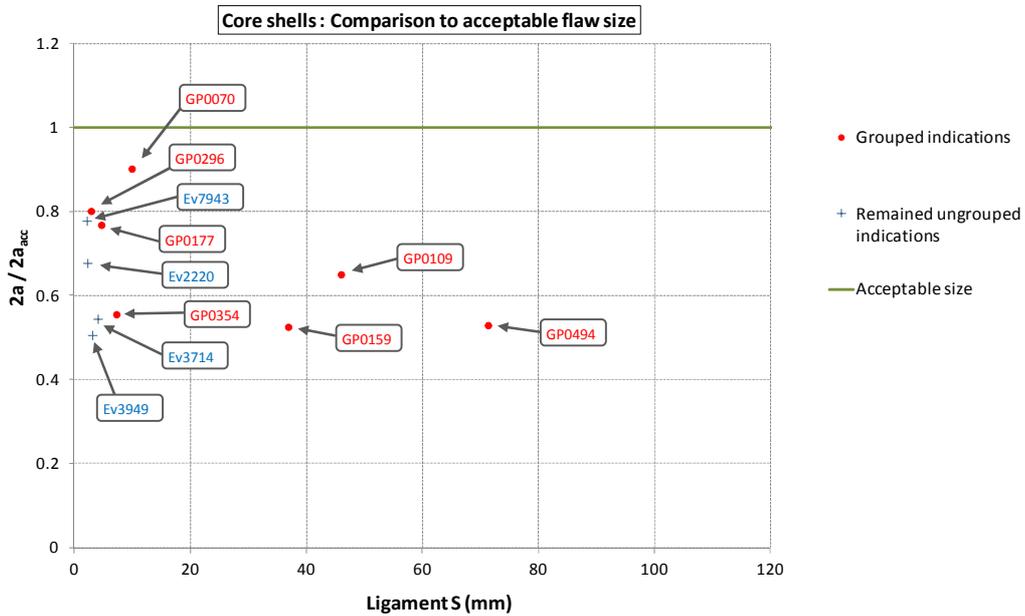
Figure 5.2: Ratio  $2a/2a_{acc}$  as a function of ligament for flaws exceeding the screening criterion

However, as Figure 5.2 shows, these flaws or groups of flaws meet the acceptability criterion (i.e. the ratio  $2a/2a_{acc} < 1$ ). In conformity with the flaw-screening approach, refined analyses were performed. They revealed substantial margins: the margin with respect to the  $2a/2a_{acc}$  ratio increases from 40% to more than 70% according to the six 3D-analyses that were performed on six configurations representative of the eleven considered here.

Figure 5.2 visualizes the flaws or groups of flaws taken into account in the analysis. The acceptability criterion (i.e. the ratio  $2a/2a_{acc} < 1$ ) is respected in every case, as shown in Table 5.1.

Nr.	$2a/2a_{acc}$	Refined $2a/2a_{acc}$	$K_{eq,max}$ (MPa√m)
GP0070	0.90	0.22	19.3
GP0296	0.80	0.28	20.5
EV7943	0.78	0.44	25.0
GP0177	0.77	0.27	20.5
EV2220	0.68	0.39	29.2
GP0494	0.53	0.09	4.6

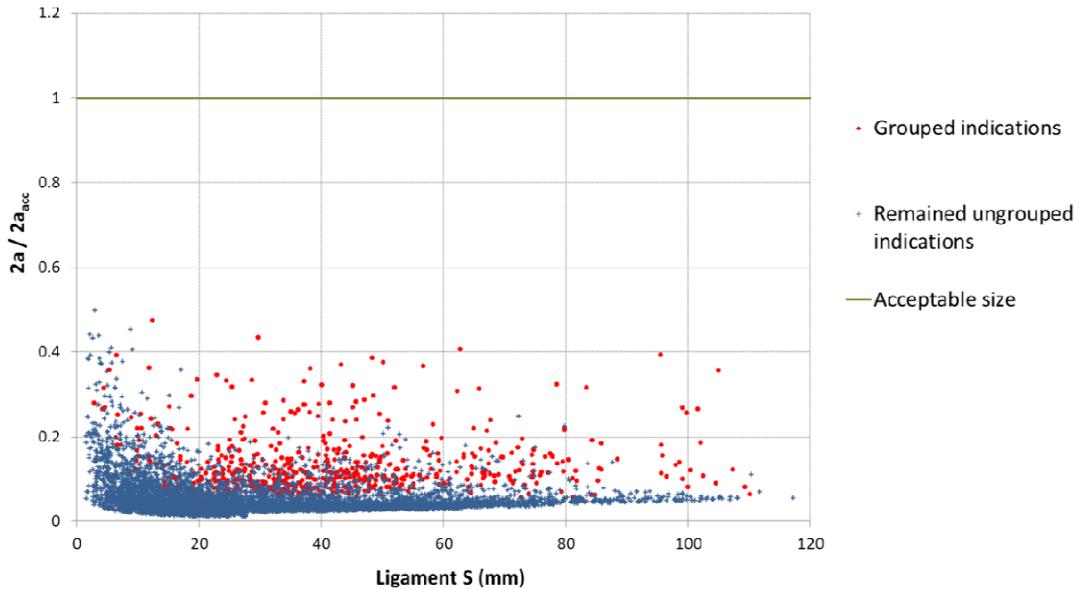
**Figure 5.3: Doel 3 core shells, comparison to acceptable flaw size (SI water at 30 °C)**

The refined analyses also take into account an increase in the Safety Injection (SI) water temperature, foreseen as an operational measure for the Doel 3 RPV in the 2012 Safety Case. This Defense-in-Depth decision was already supported by the SCP in its 2012 advice report regarding the Doel 3 RPV Safety Case. Indeed, in the Doel 3 RPV, most of the flaws close to the acceptable flaw size are located near the inner surface, which is not the case for the Tihange 2 RPV.

Finally, the SCP Review Team confirms its confidence in the demonstration of the structural integrity of the Doel 3 RPV, since the results of the refined analyses (see Figure 5.3), show a margin higher than 50 % with respect to the acceptability criterion ( $2a/2a_{acc} < 1$ ).
