**REPORT ON INDEPENDENT  
ANALYSIS AND ADVICE  
REGARDING THE SAFETY CASE  
ADDENDUM**

# **Tihange 2**

## **Reactor Pressure Vessel Assessment**

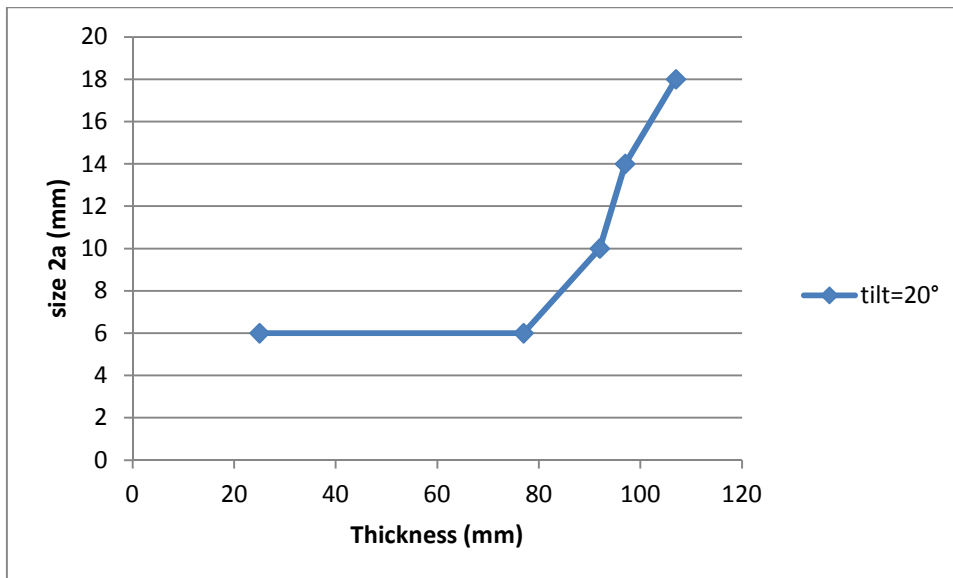
The Safety Authorities requested the performance of a sensitivity study of mechanical integrity. An envelope curve for the size of a potentially unreported flaw was determined in order to obtain a realistic basis to add potentially unreported flaws. Based on that input, the Project Team simulated various flaw configurations (orientation, size, tilt). The curve below represents the maximum size of a potentially unreported flaw with a conservative 20° tilt. This is the main input for the sensitivity analysis (see Chapter 5.3).

**Figure 2.1: Size of the largest flaws with 20° inclination potentially not reported by UT inspection**
