**SAFETY CASE REPORT**

**ADDENDUM**

# **Doel 3**

## **Reactor Pressure Vessel Assessment**

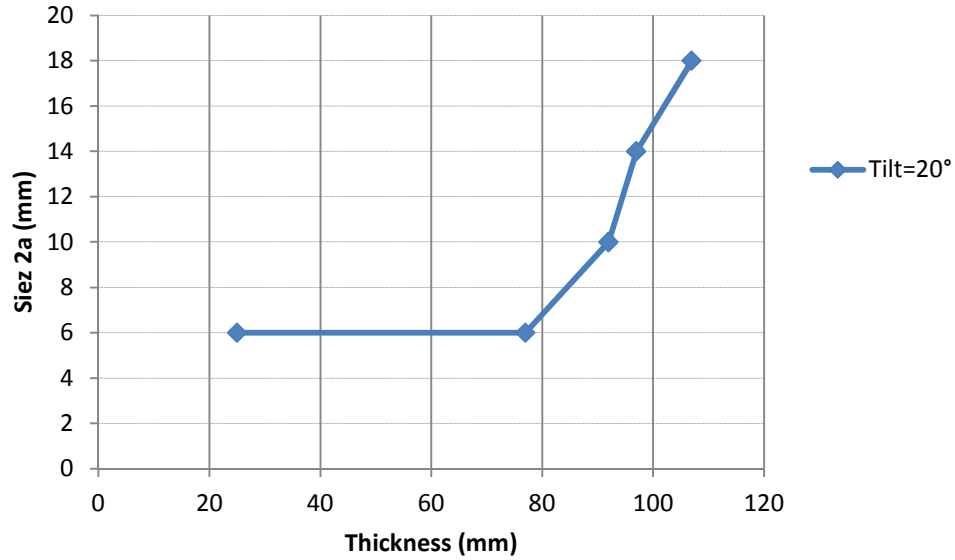
**Figure 2.1: Size of the largest flaws with 20° inclination potentially not reported by UT inspection**

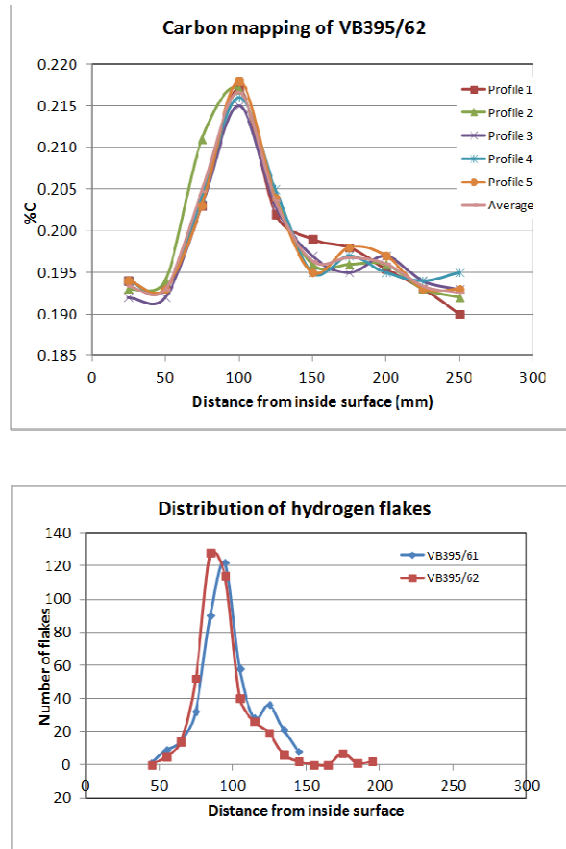
For the VB395/62 block, the carbon segregation profile has been compared to the distribution of flakes through the thickness, showing a one-to-one correspondence, as shown below. This confirms that the flaking occurs in macro-segregated areas.

Figure 3.2, top: Carbon mapping, bottom: Distribution of indications in function of the position in depth

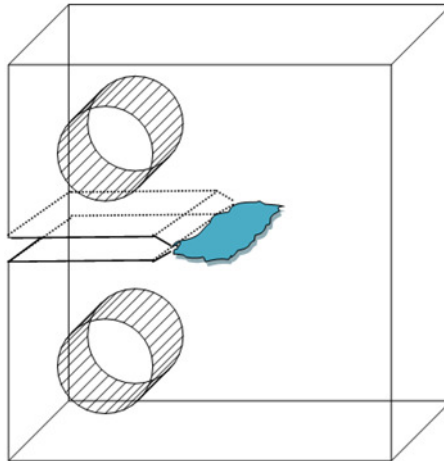
- **Fracture toughness tests were performed on specimens with a hydrogen flake as crack initiator** (in place of the usual fatigue crack), as shown on the figure below. The preparation of such specimens is complex and these tests do not fulfil the standard requirements in terms of crack front regularity, however the measured values are confirmed by 3D Finite Element Analysis. The test results are close to the ones obtained on the ligament between flakes, with an increase of the Master Curve Reference Temperature  $T_0$  of the order of 14 °C.

**Figure 4.2: CT12.5 specimen with a hydrogen flake at the crack tip for direct measurement of toughness at the tip of the flake**

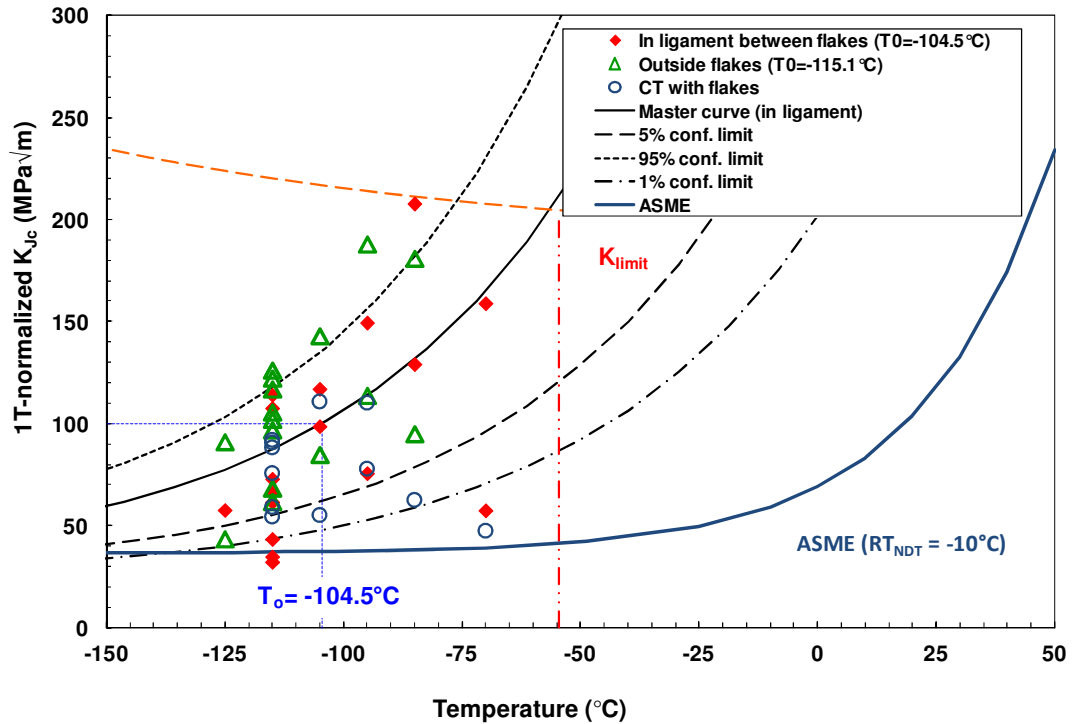
- All results are compared in the figure below. For clarity only the Master Curves for the specimens taken in the ligaments between flakes are represented. All results are enveloped by the ASME curve indexed on the  $RT_{NDT}$  of this material, except for two points at very low temperature ( $-115\text{ }^{\circ}\text{C}$ ), which are not relevant with regard to operating conditions.
- The surveillance results for the Doel 3 and Tihange 2 RPVs have shown that the effect of embrittlement, as evaluated by the FIS formula, is conservative. This led to a margin of 10 to 25  $^{\circ}\text{C}$  which is not taken into account in the evaluation.
- The results confirm the conservativeness of the 50  $^{\circ}\text{C}$  margin on  $RT_{NDT}$  considered in the structural integrity analyses.

Figure 4.3: Comparison of fracture toughness of the VB395/61 material in the ligament between flakes and in the material free of flakes

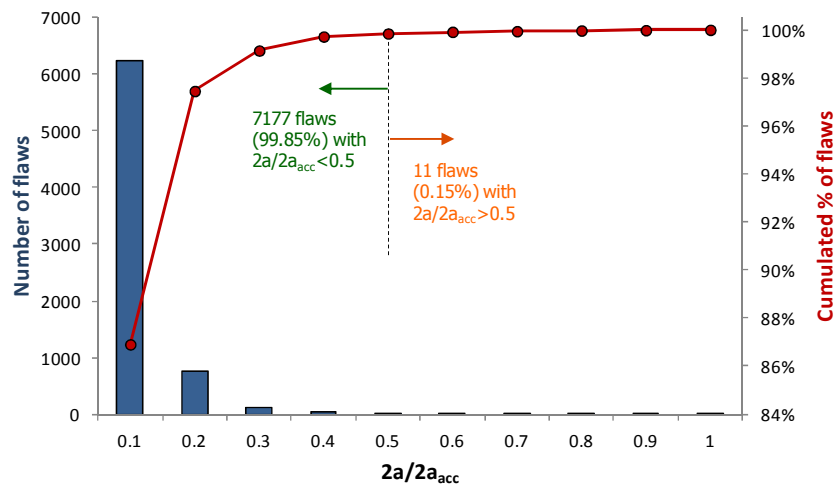
Applying the flaw-screening criterion to the flaws detected in the RPV core shells of Doel 3 shows that eleven flaws (isolated or grouped) exceed the flaw-screening criterion, as illustrated here:

Figure 5.2: Flaw-screening criterion applied to core shells of Doel 3

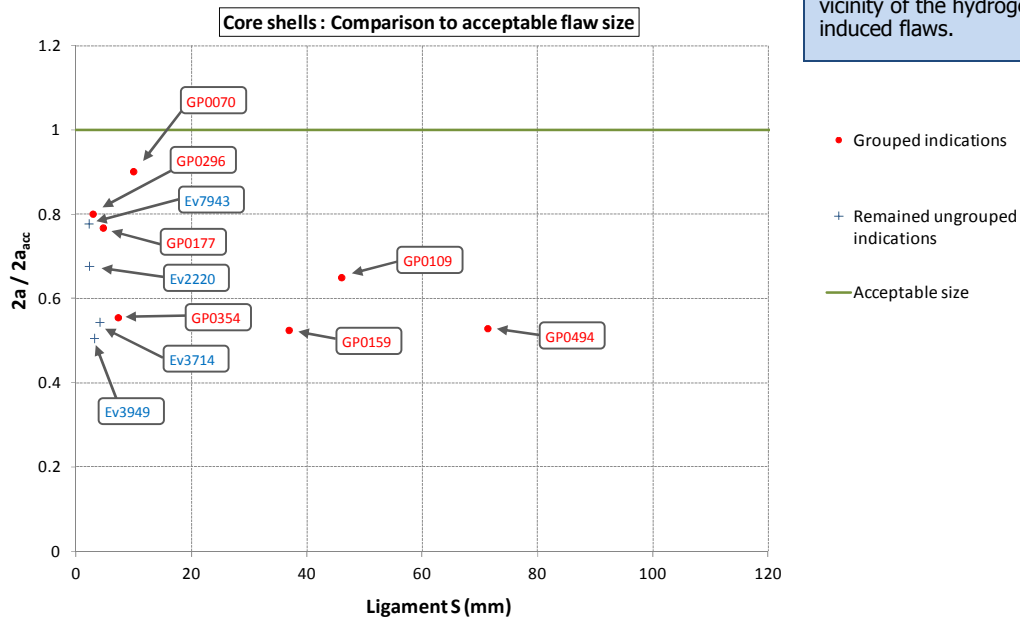
**Figure 5.3: Ratio  $2a/2a_{acc}$  as a function of ligament for flaws exceeding the screening criterion**

In the above figure, grouped flaws are labelled by 'GP' followed by the flaw number. Individual flaws are labelled by 'Ev' followed by the flaw number.

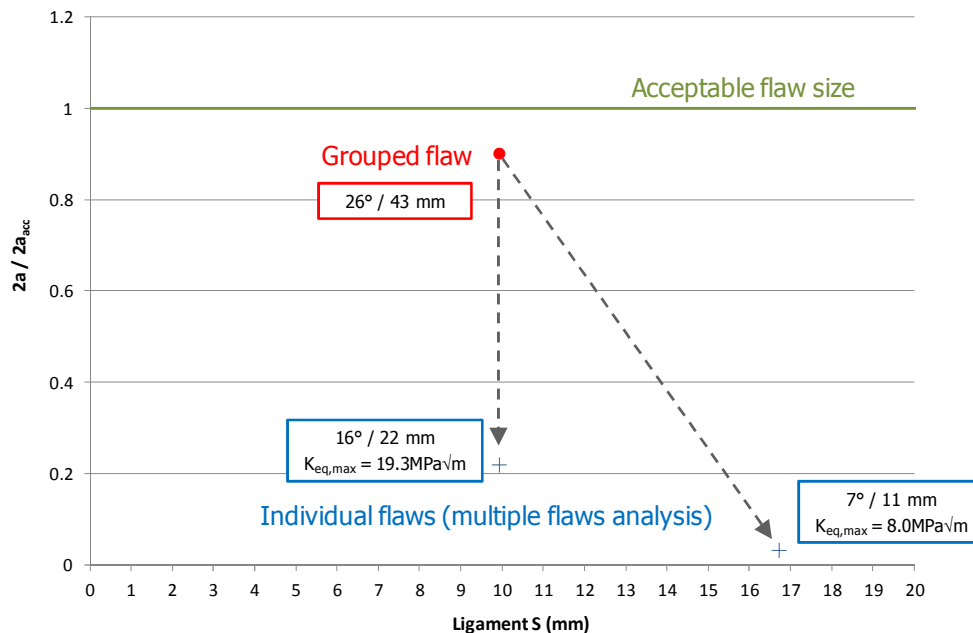
As an example, Figure 5.4 illustrates the analysis of the grouped flaw GP0070 depicted in Figure 5.3. The margin with respect to the acceptable flaw size increases from 10% for the grouped flaw approach to more than 75% when considering a 3D analysis of the multiple flaw configuration. Also given in this figure are the inclinations and flaw diameters considered for the grouped flaw on one hand and for the individual flaws on the other hand.

Figure 5.4: Refined analysis of grouped flaw GP0070

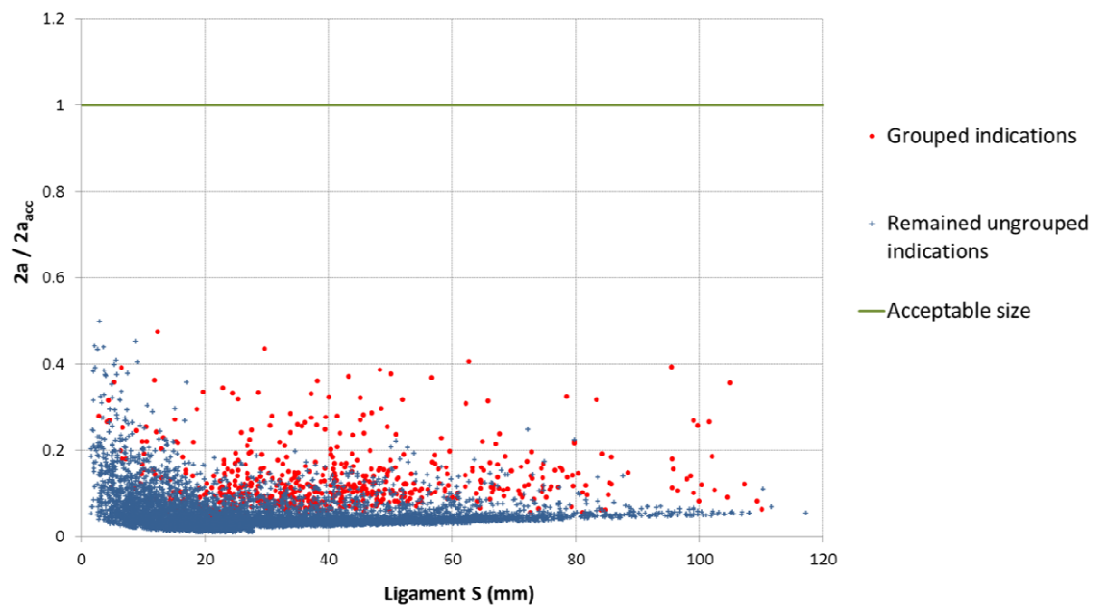
Finally, the  $2a/2a_{acc}$  ratios for all flaws in the core shells of the Doel 3 RPV, including the results of the refined analyses, are represented in the following plot as a function of the flaw ligament.

Figure 5.5: Core shells, comparison to acceptable flaw size

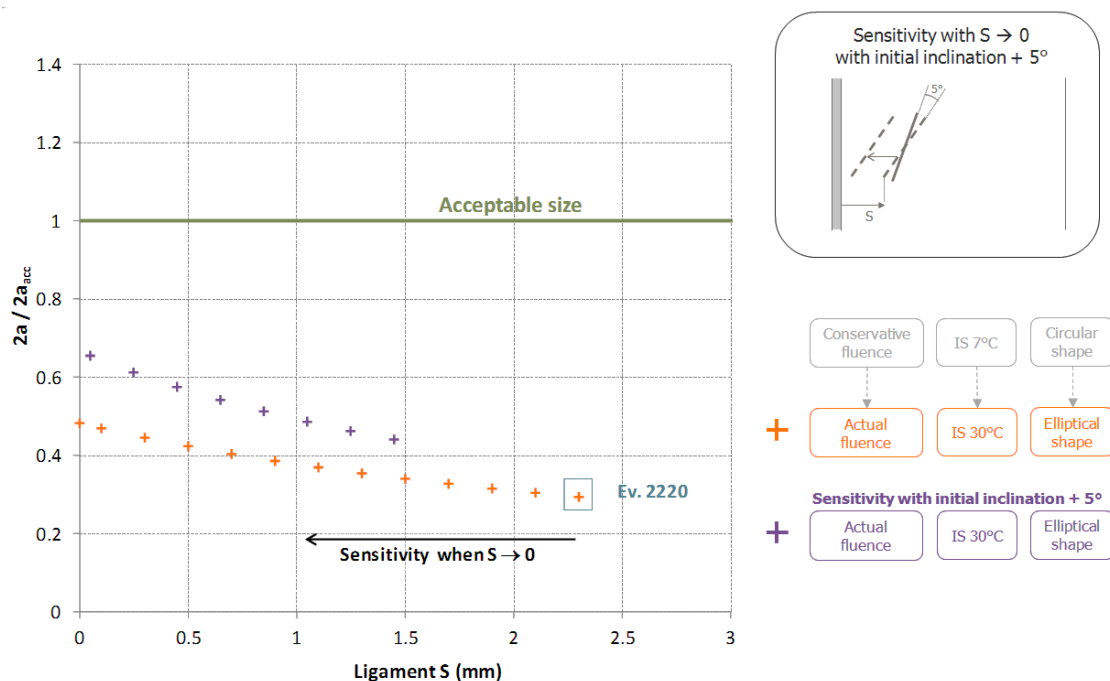
A number of sensitivity analyses were performed on the most penalizing flaw of the two RPVs (Doel 3 flaw Ev2220), considering effects such as the ligament tending to zero, a 5° larger inclination, the actual fluence, the flaw shape, and the Safety Injection water temperature. Results confirm that a significant margin remains in all cases. The figure below shows the evolution of the margin with respect to the acceptability criterion with the ligament  $S$  tending to zero.

Figure 5.6: Sensitivity analysis for  $S \rightarrow 0$  combined with effect of a 5° increase of the inclination of the Doel 3 flaw (Ev2220)

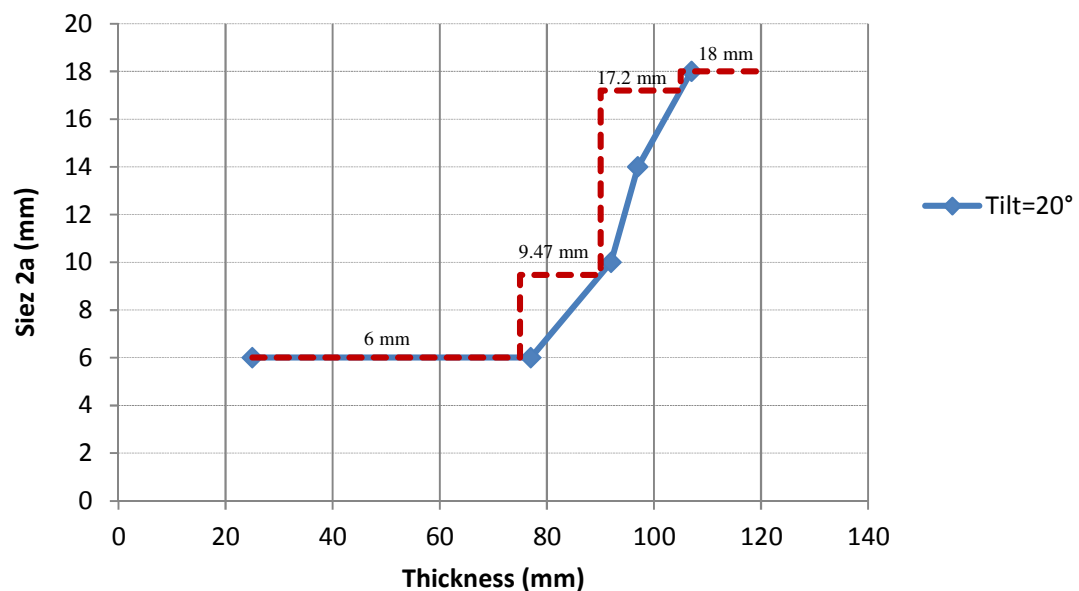
The outcome of this action is the solid blue line in the figure below. It is an envelope curve that defines the size of the largest flaw with a 20° inclination that would potentially not have been reported, as a function of the position in the RPV wall in the depth range between 25 and 120 mm.

Figure 5.7: Size of largest potentially unreported higher tilted flaw (20° tilt)

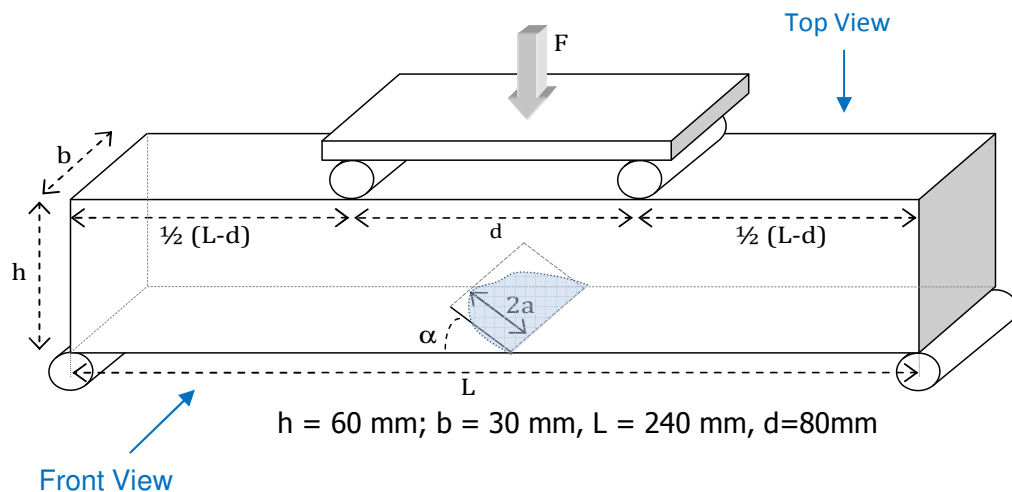
The Structural Integrity Assessment demonstrated that the Doel 3 RPV shells meet the required margins against crack initiation for all operating conditions. This means that any experiment that is fully representative of the real configuration and loading conditions of the RPV shells will never lead to brittle crack initiation, even when not assuming a fracture toughness value at the lower bound of the ASME curve. Therefore, test conditions must be more severe. Preliminary analyses showed that more severe conditions can be obtained by subjecting a bend bar of 30x60x260 mm with a surface-breaking flaw in the high-stress region to a four-point bending test at a temperature as low as  $-130^\circ\text{C}$  (see Figure 5.8).

Figure 5.8: Four-point bend specimen with surface breaking flake

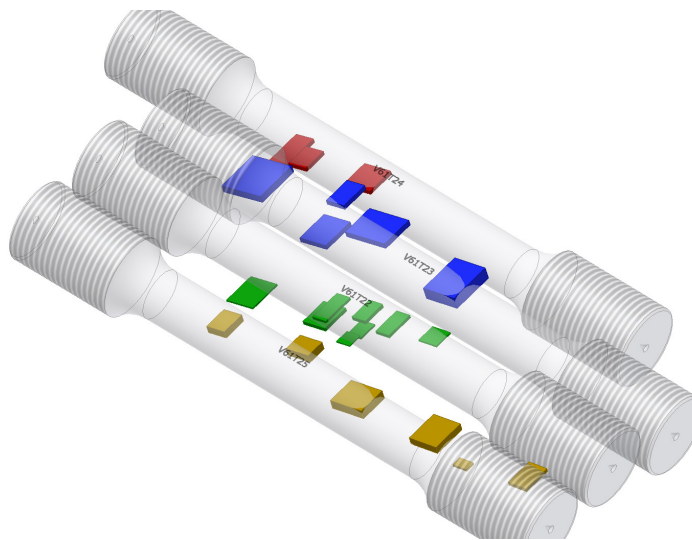
Tensile tests were performed on four large specimens (25 mm diameter) taken from the VB395 shell. The specimens contain multiple hydrogen flakes oriented at 20° with respect to the specimen axis as shown in Figure 5.9.

**Figure 5.9: 3D view of the tensile test specimens with flakes tilted 20° with respect to specimen axis. The flakes are represented by coloured boxes that envelope the actual flakes.**
