SAFETY CASE 2015

Doel 3

Reactor Pressure Vessel Assessment

28 10 2015

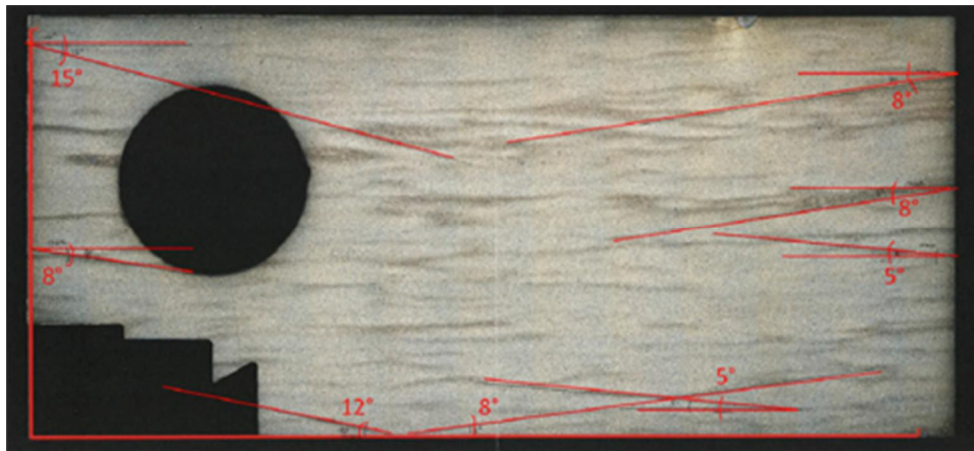
Figure 3.3: Example of inclination measurement (D3H1, axial direction).

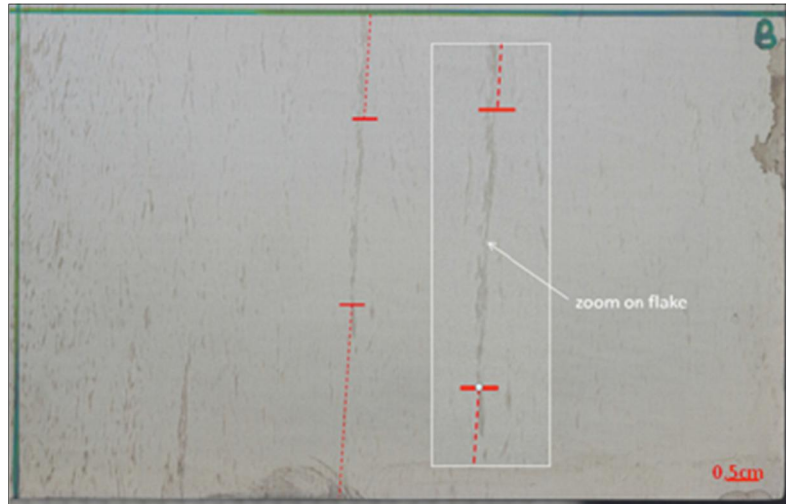
Figure 3.4: Detail of inclination measurement (VB395/1, axial direction).

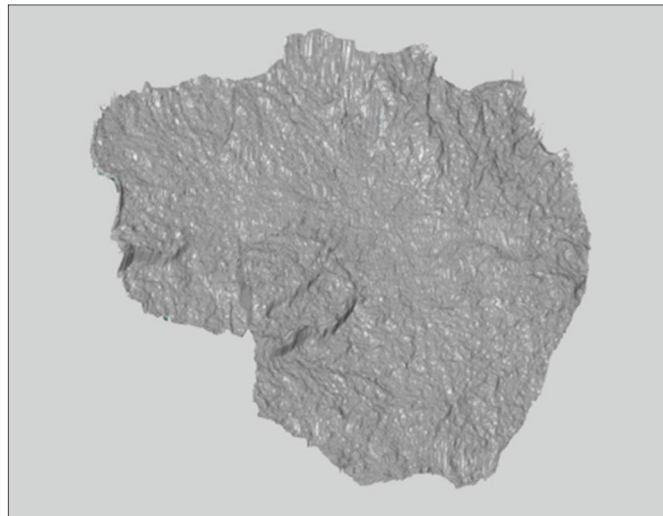
To get an accurate picture of the flakes' faceting (Figure 3.5), successive cross sections of the flakes were made, resulting in a series of crack profiles. These profiles were then superimposed and projected onto a single plane. This made it possible to estimate the degree of faceting. Finally, 3D profiling was applied.

Figure 3.5: Typical flake appearance.

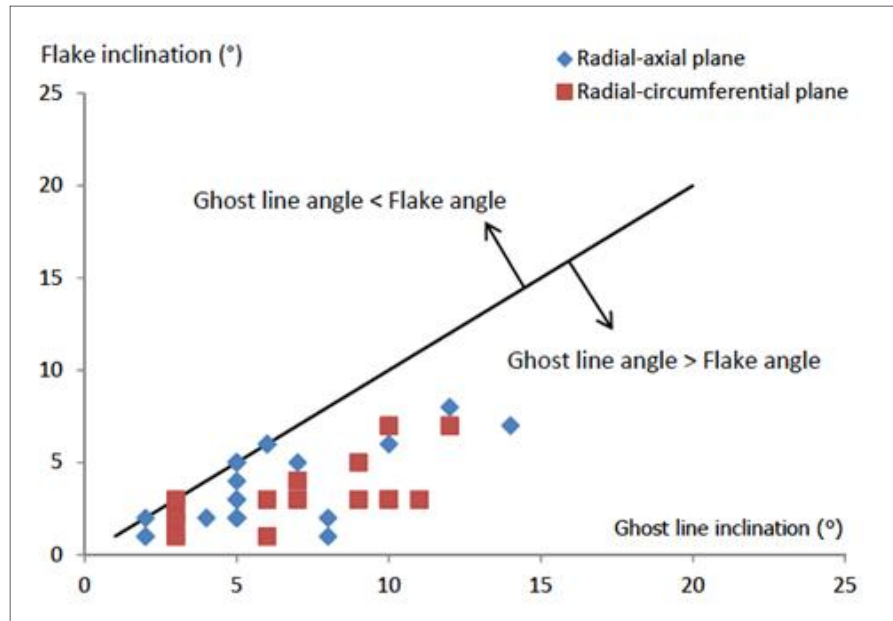
- The observations confirmed that the flakes are located in ghost lines, primarily in those with the highest level of segregation.
- The flakes tend to remain in the laminar direction even when the hosting ghost line deviates.
- The correlation between ghost line inclination and flake inclination was evaluated on several flakes. The average flake inclination is approximately 4° while the average ghost line inclination is approximately 7° . The investigation revealed that the flakes are systematically less inclined than the maximum ghost line inclination (Figure 3.6).

Figure 3.6: The flakes are systematically less inclined than the ghost lines (representative sample).

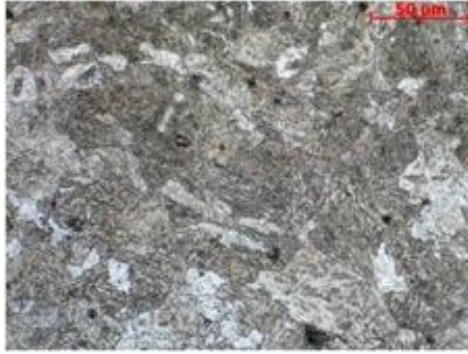
Figure 5.6: D3H1: dark zone microstructure: mostly lower bainite (red scale 50 μm).

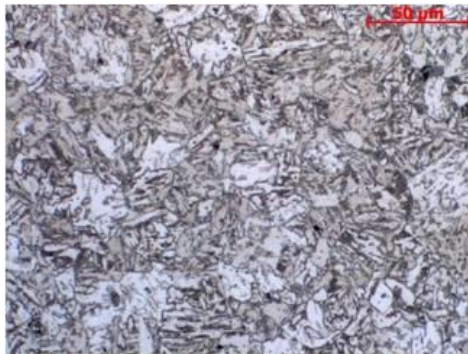
Figure 5.7: D3H1: light zone microstructure: upper bainite (red scale 50 μm).

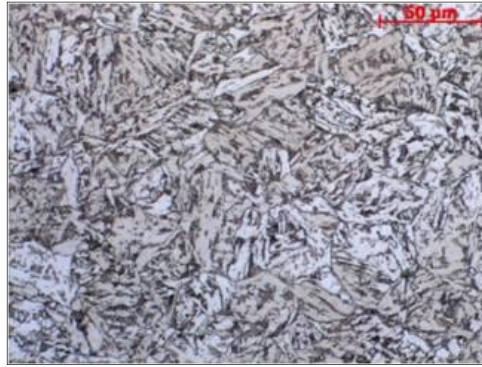
VB395 has globally a similar microstructure in the dark and light zones (Figure 5.8) as D3T2 RPVs, with similar grain sizes, although a bit smaller than observed in D3H1. However, VB395 presents more tempered martensite in the dark zones (Figure 5.9), compared to D3T2, as well as less coarse precipitates. The dark zones form a marked segregation network. This trend is more pronounced for VB395/6BF (material between flakes – BF) than for VB395/5 and VB395/6OF (material outside of flakes – OF).

Figure 5.8: VB395/6BF: light zone microstructure: upper bainite (red scale 50 μm).

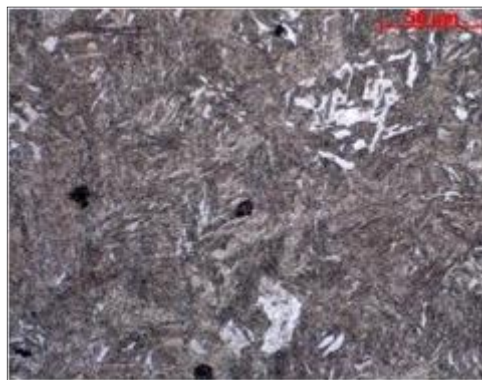
Figure 5.9: VB395/6BF: dark zone microstructure: tempered martensite (red scale 50 μm).

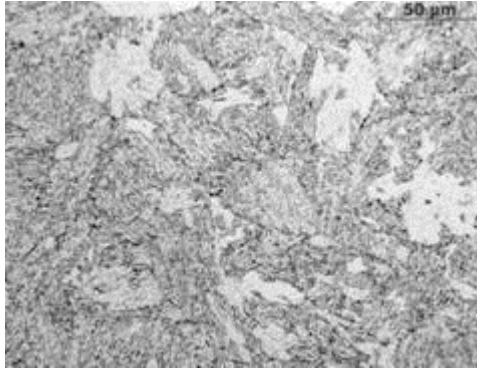
Figure 5.10: KS 02: dark zone microstructure: mostly tempered bainite (black scale 50 µm).

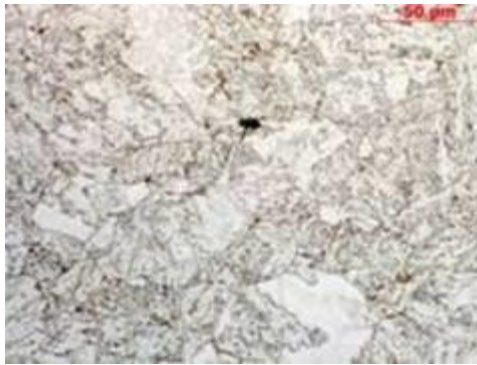
Figure 5.11: KS 02: light zone microstructure: mostly upper bainite (red scale 50 µm).
