**REPORT ON
INDEPENDENT ANALYSIS
AND ADVICE REGARDING
THE SAFETY CASE 2015**

Tihange 2
**Reactor Pressure Vessel
Assessment**

V1 03 November 2015 •

Electrabel
GDF SUEZ

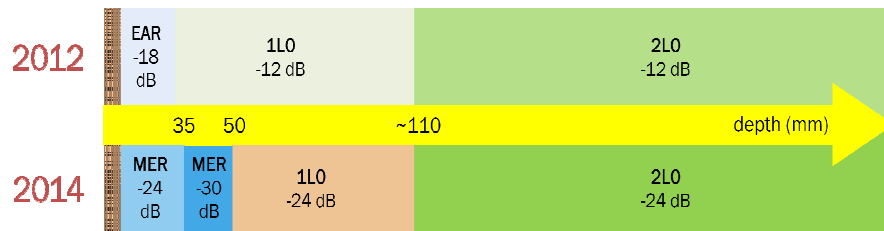
To illustrate the selection of the rejection threshold and the use of the sensors, Figure 1 shows clearly the old and new values used.

Figure 1: Evolution of the rejection thresholds between 2012 and 2014

The final consolidated results of the qualification confirmed that the MER sensor provided a level of performance similar to the EAR but that its response was better at near depths inside the material (especially <30 mm). At higher depths, the rejection threshold has been lowered to maintain the detection capability.

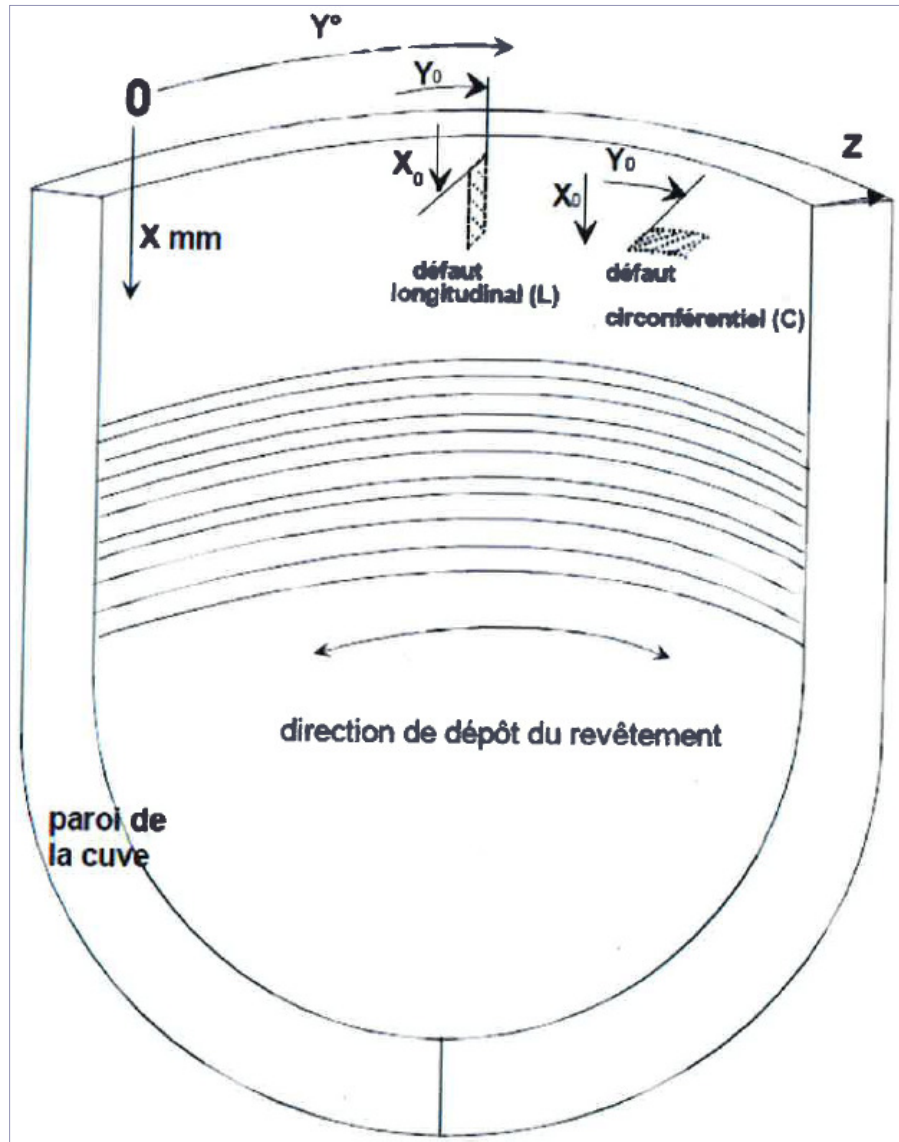
The reference used when describing the flaws is depicted in Figure 2. The flaws are quasi-laminar, which means that their components are almost totally included in the XY plane, i.e; parallel to the cladding.

Figure 2: Axis system used in MIS-B Qualification

It is of utmost importance to remember that the hydrogen flaking defects are quasi-laminar defects. This means that, according to the reference that was used (Figure 2), they have their components in the XY plane and almost no Z (radial) component.

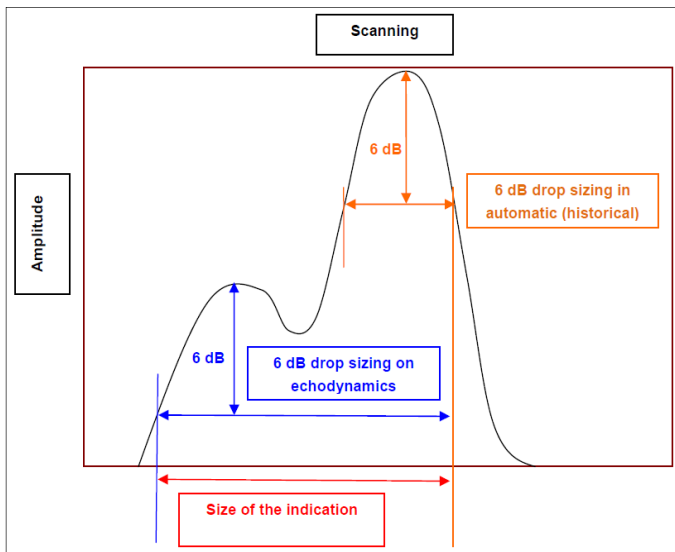
The principle of the echo-dynamics methodology is illustrated in Figure 3. When the UT sensor is placed along the surface, the usual sizing methodology aims at calculating a drop of 6 dB with respect to the maximum peak in amplitude. The size of the indication is then calculated as the distance between the two points from part and other of the maximum giving the -6dB loss of signal. This procedure is fully automated.

Destructive tests on the VB395 test blocks showed that sometimes this procedure led to the underestimation of the size of the actual flaw. Indeed, some part of the signal was considered as rejected noise because out of the 6db drop of the absolute maximum. The echo-dynamics procedure enables correction of this. It calculates the length of the indication by using the 6dB drop not only from the absolute maximum but also considering secondary (local) maxima that could be in the vicinity of the global maximum. As such, the sizing is improved.

Figure 3: Representation of the echo-dynamics methodology

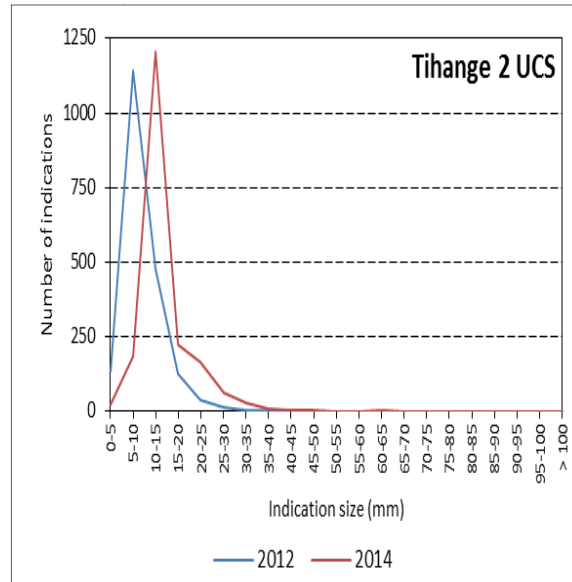
Figure 5: Indication size distributions (UCS: Upper Core Shell) based on the 2012 or 2014 methodology with the 2012 raw data

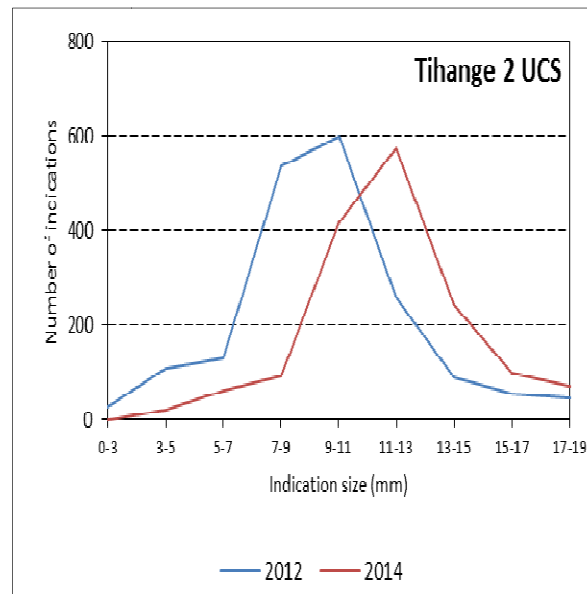
Figure 6: Small size distributions (UCS: Upper Core Shell) based on the 2012 or 2014 methodology with the 2012 raw data

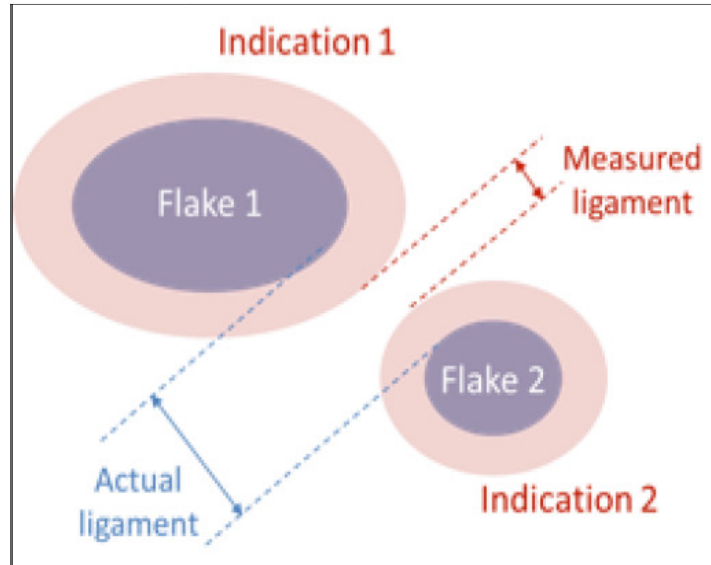
As illustrated in Figure 7, the increased sizes measured by the 2014 methodology (illustrated in pink) reduce in some cases the possibility of detecting sound metal between two indications (namely when the measured ligaments tends to zero) ; in such a case, only one larger indication is reported, thereby reducing the total number of flaw indications. The revised sizing methodology applied in 2014 resulted in a slight increase in the indication dimensions compared to 2012. However, the indication size distributions (see Figure 5 and 6) observed in the core shells remained unchanged.

Figure 7: Undersizing the sound metal ligament between two oversized neighbouring flaws

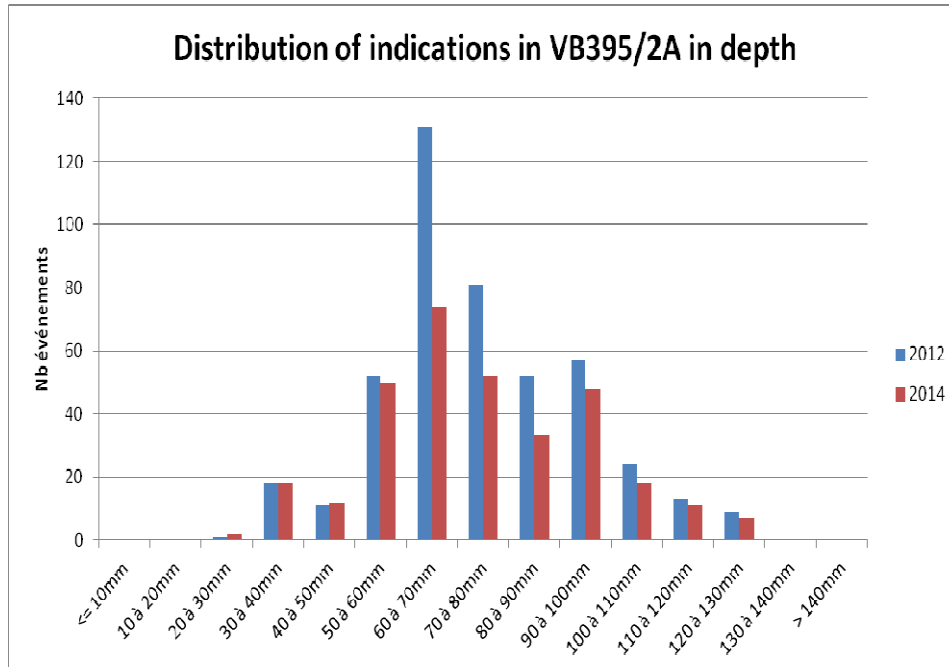
The reanalysis revealed that the same behaviour was observed on the VB395/2A block: a reduction of the number of indications but an increase in size (Figure 8, Table 9)¹.

Figure 8: Distribution of the number of indications with respect to the depth—VB395/2A

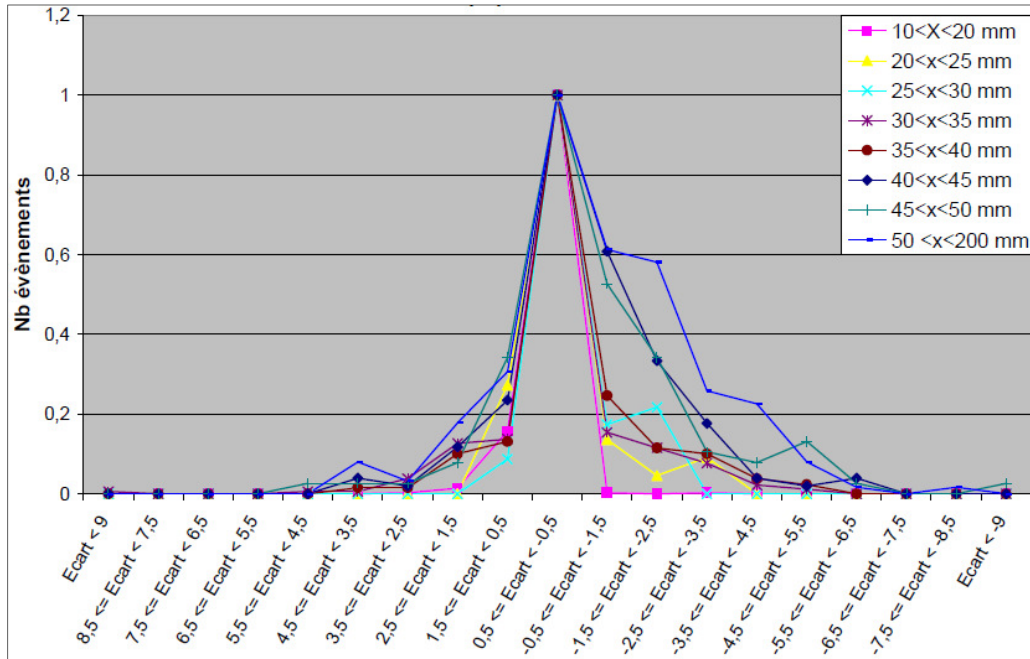
Figure 10: Normalized histogram of the delta in DZ sizing (usual sizing—alternative sizing)

It appears that the results are equivalent up to 20 mm. For the largest indications, it can also be concluded that the 'alternative' methodology gives statistically larger dimensions in DZ.

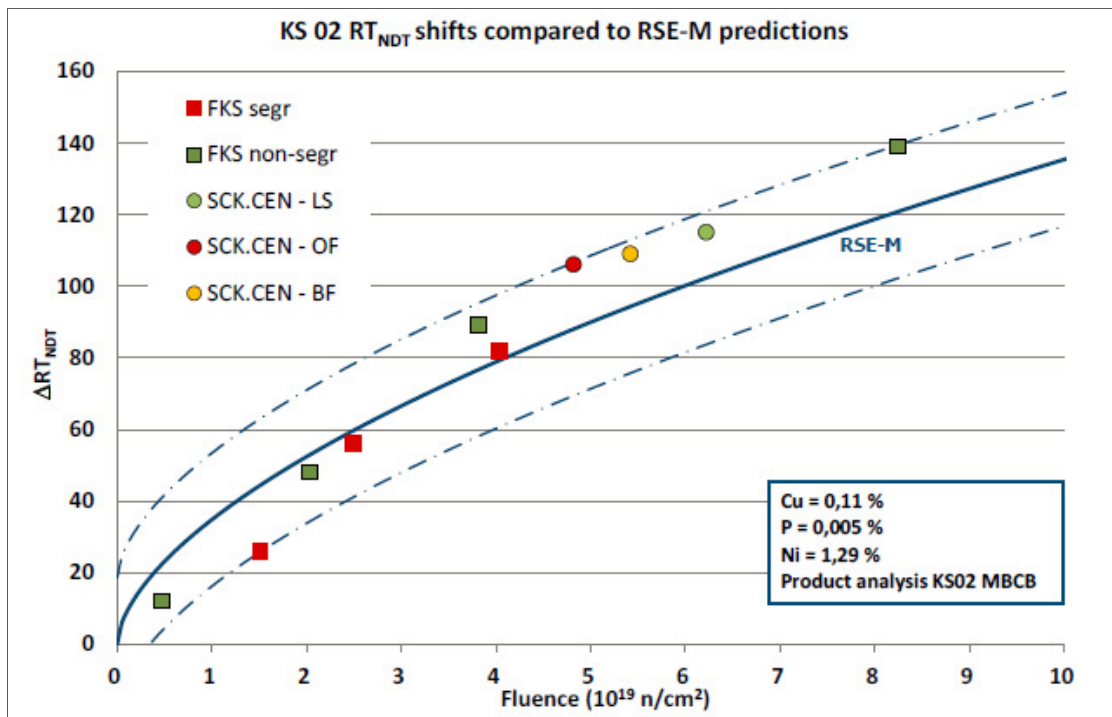
Figure 11 shows the measured values of the shift which are in accordance with the RSE-M prediction and Figure 12 shows the results of the measured values of ΔT_0 . For a proper understanding of the legend in this last figure, note that 'FKS non segregated' and 'AREVA segregated' are designating respectively the KS 02 out of the macro segregated area and the KS 02 broken specimens after Charpy tests reconstructed by AREVA Erlangen. Therefore, both are applicable for the KS 02 material.

Figure 11: Shift in RT_{NDT} ($\Delta T=41J$) versus fluence (LS = 'Less Segregated Zone', OF = 'out of flakes', BF = 'Between Flakes')

Both figures show consistent results.

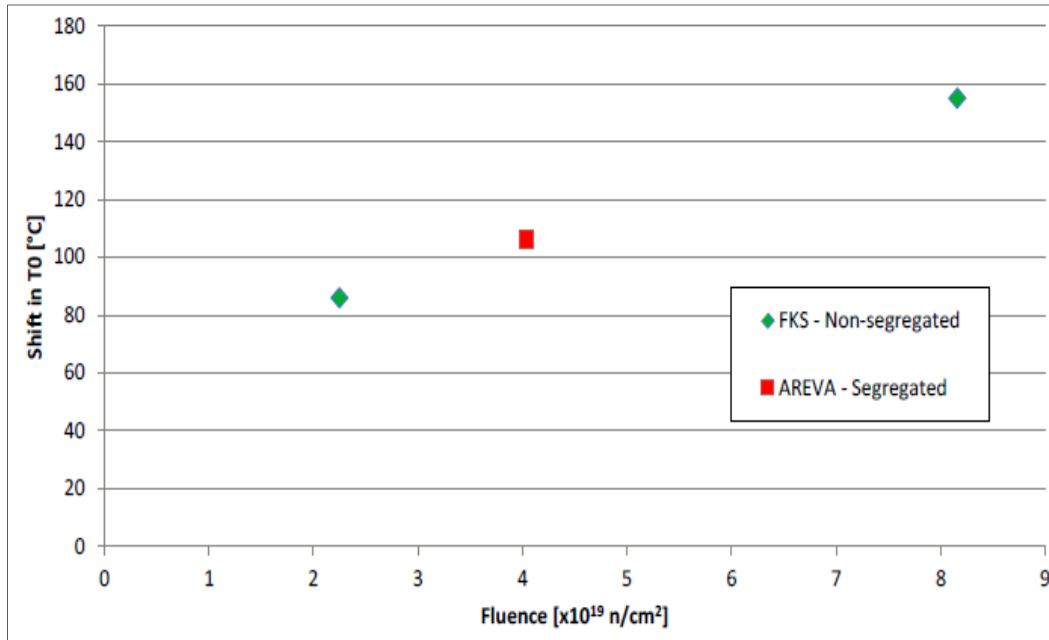
Figure 12: Shift in T₀ versus fluence for KS 02 B

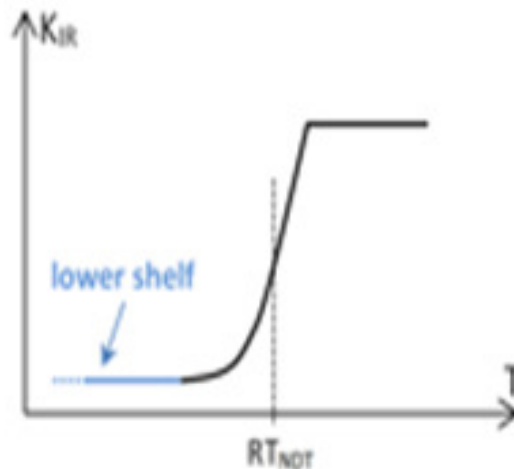
The fracture toughness K_{IR} is a function of temperature T and RT_{NDT} . For temperatures lower than the RT_{NDT} , the K_{IR} curve tends to a lower shelf (see figure 14 here after). Therefore, when the crack driving force K of a flaw is lower than the toughness lower shelf, no crack initiation is expected to occur regardless of T and RT_{NDT} values”.

Figure 14: Fracture toughness lower shelf

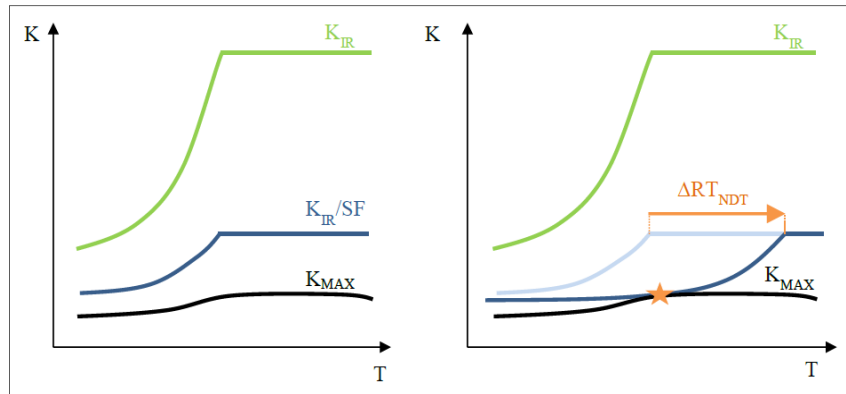
One way to determine the margin on the RT_{NDT} is to shift the curve of the crack driving force to find its intersection (if any) with the fracture toughness (divided by the safety factor) curve. The value of the shift gives the RT_{NDT} margin. This is illustrated at the Figure 15.

Figure 15: Determination of the RT_{NDT} margin

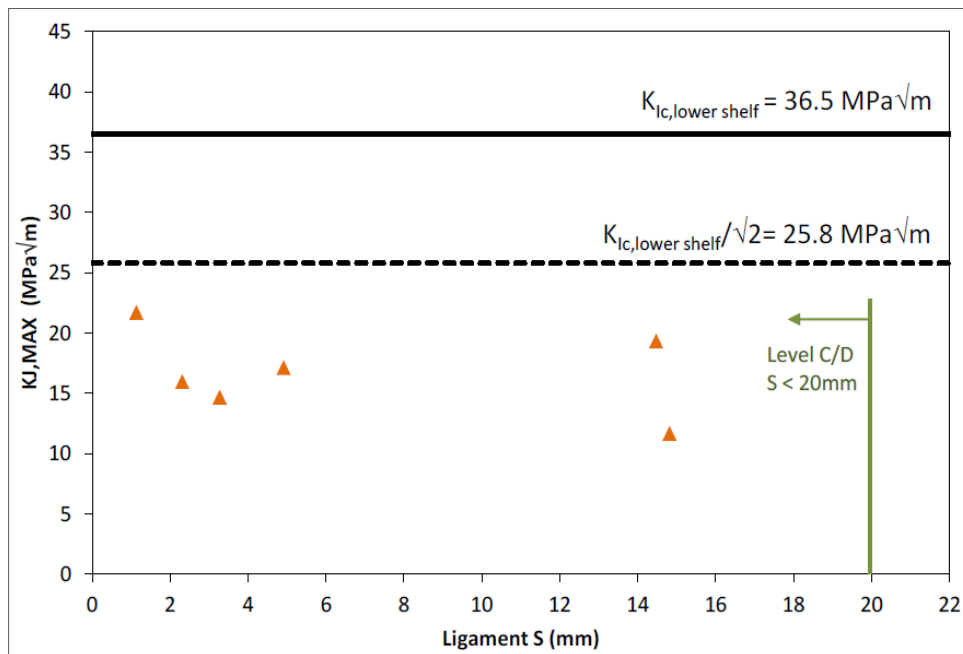
As can be seen in Figure 16 and Figure 17, the results of the calculations to select most penalizing criterion (in this case the flaw with the highest radial projection Δz) give values which are always lower than the lower shelf.

Figure 16: $K_{I,max}$ values compared to lower shelf toughness for flaws close to the cladding-base metal interface

It can be seen in Figure 16 that there is no point above the lower shelf divided by the safety factor in the first 20 mm of the reactor pressure wall.

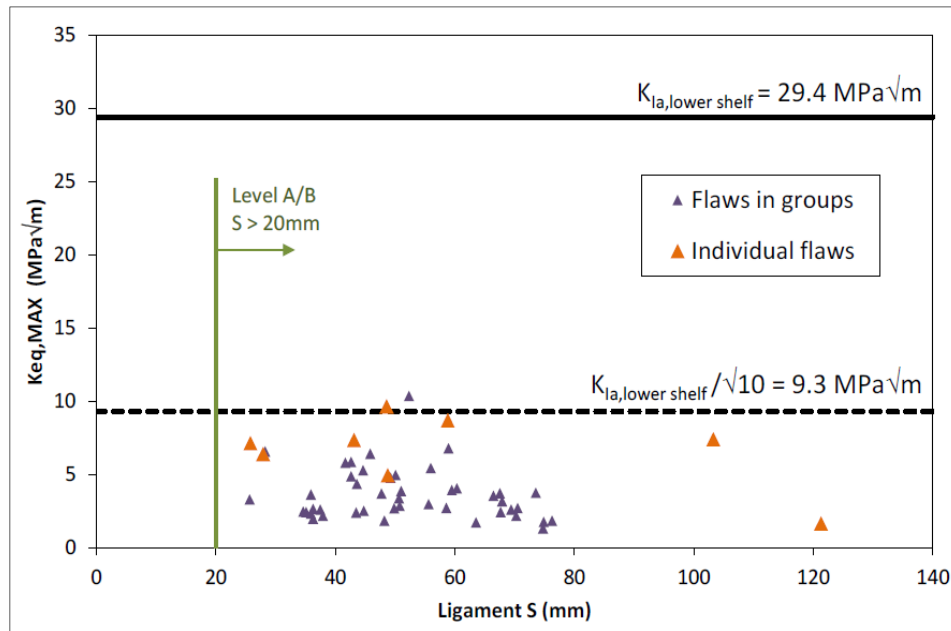
Figure 17: $K_{eq,max}$ values compared to lower shelf toughness for flaws far from the cladding-base metal interface

As can be seen in Figure 17, at deeper thicknesses inside the RPV wall, two configurations are leading to values above of the lower shelf divided by the safety factor (but none above the lower shelf itself).

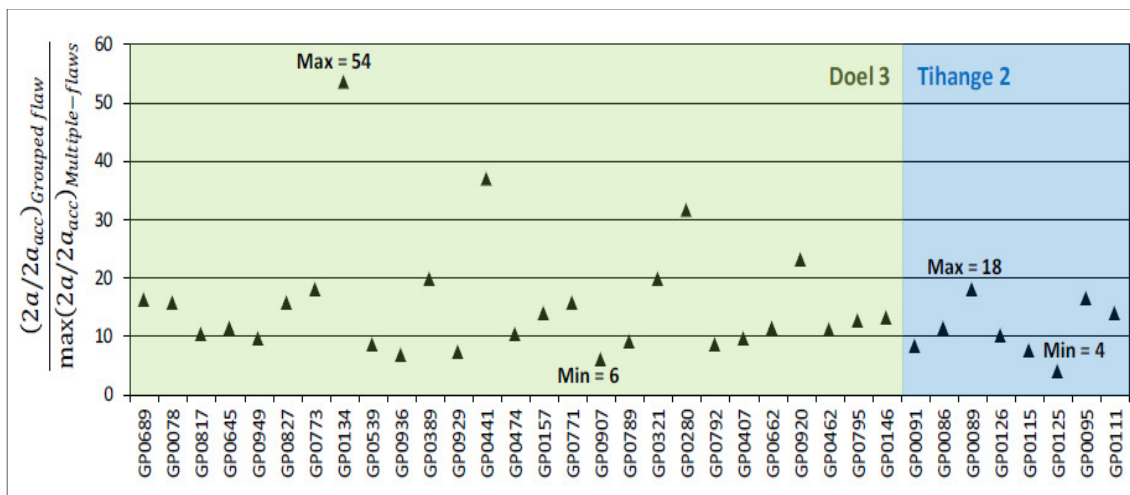
Concerning the ASME XI compliancy, the larger conservativeness is linked to the grouping criteria as illustrated by the refined analyses performed on grouped flaws of the Doel 3 and Tihange 2 RPVs. Figure 18 shows that the conservativeness expressed in terms of the ratio flaw size to acceptable flaw size ($2a/2a_{acc}$) are very important. Indeed, this ratio calculated for a group of flaws is divided by a factor 4 to 18 (in the case of Tihange 2) for each of the grouped flaws when the refined analysis of this group is performed.

Figure 18: Impact on the refined analysis for the Doel 3 and Tihange 2 RPVs
