**SAFETY CASE REPORT**

**ADDENDUM**

# **Doel 3**

## **Reactor Pressure Vessel Assessment**

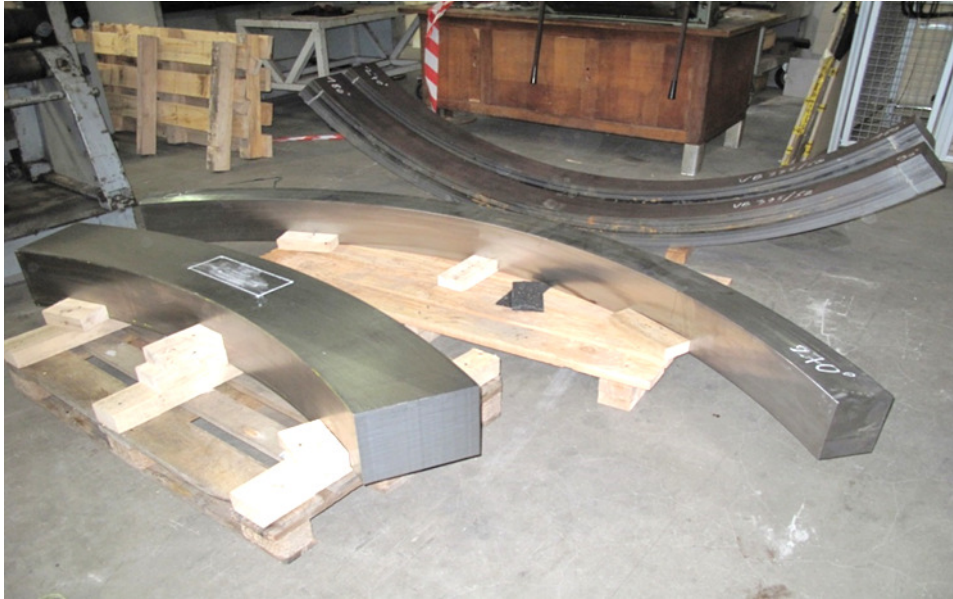
Figure 4.1: Blocks from AREVA shell VB395

An extensive testing program was performed on different blocks extracted from the VB395 shell, both in a zone free of flakes (as reference) and in a zone affected by flakes. A total of 172 specimens of different types were tested.

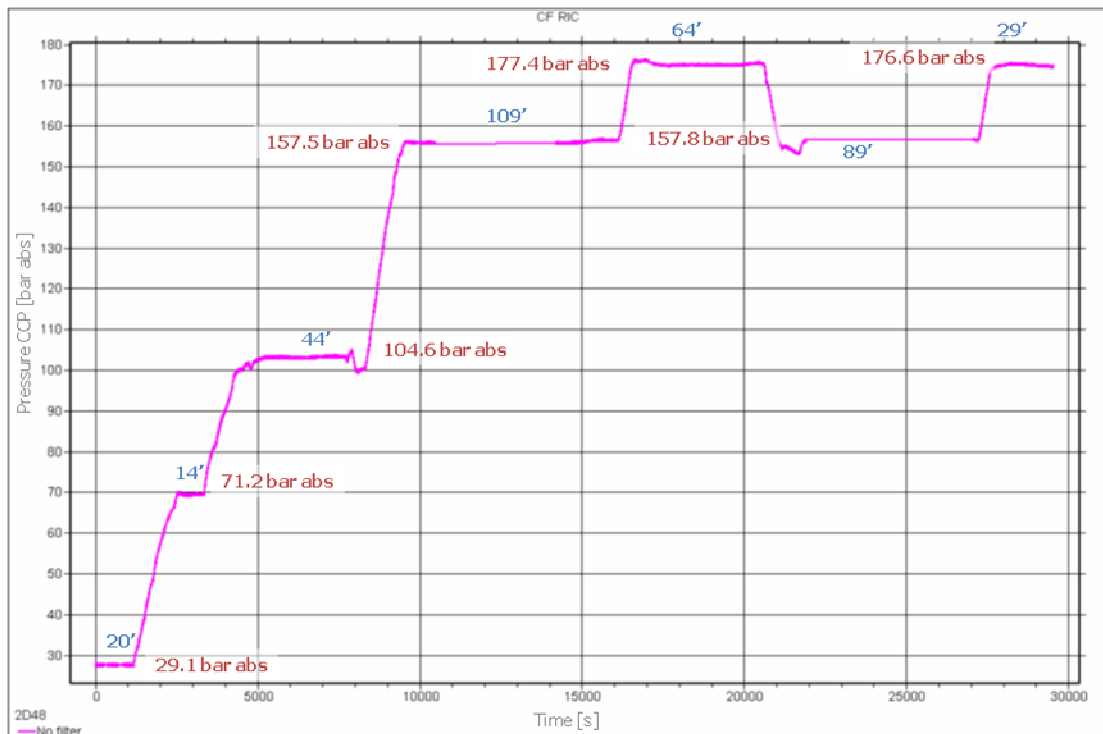
Figure 6.1: Primary pressure evolution during the load test

The primary pressure evolution during the load test was in accordance with the Electrabel procedure and AE requirements and is given in Figure 6.1. There were two test plateaus at about 177 bar abs of respectively one hour and 30 minutes separated by a lower plateau at 158 bar abs. This enabled the detection of potential AE reactivation at a lower pressure level.

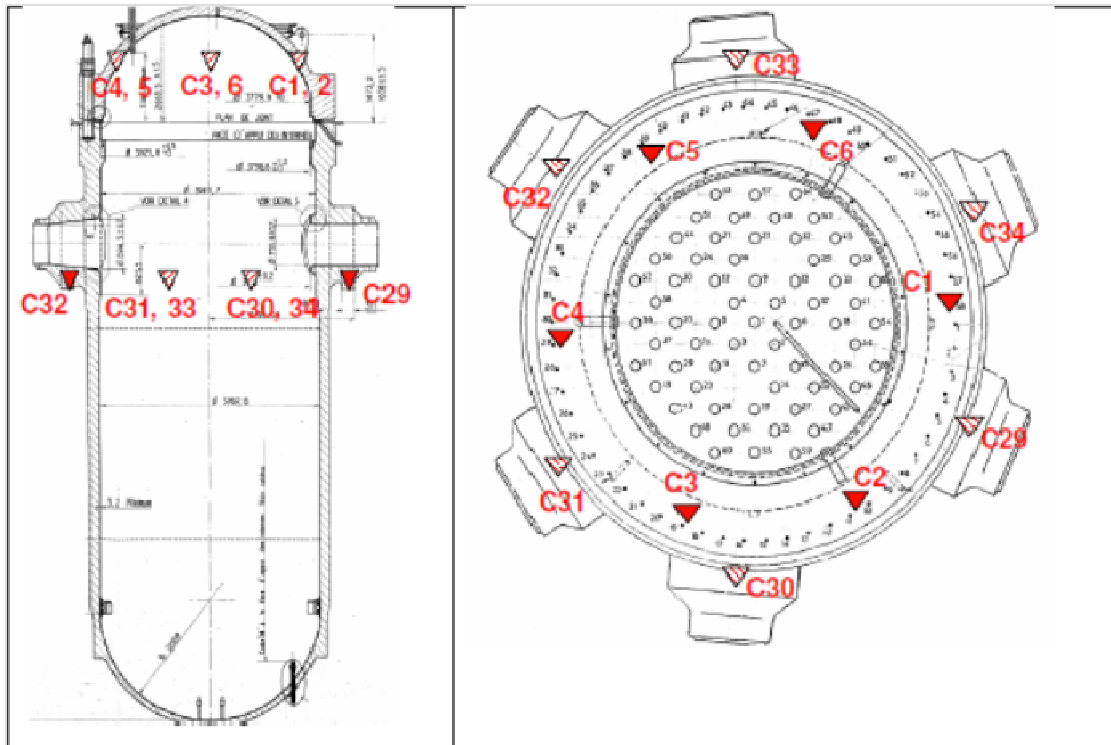
**Figure 6.2: Location of the sensors on the RVH (C1 to C6 and on the RPV nozzles (C29 to C34)**

The goal of the Acoustic Emission (AE) test was to detect the propagation of flaws in the RPV core shells, if any. In order to reach this objective, the Doel 3 RPV was equipped with fifteen sensors (see Figure 6.2):

- Six sensors on the Reactor Vessel Head.
- Six sensors on the RPV inlet and outlet nozzles.
- Three sensors on the in-core instrumentation connected to the bottom of the RPV.

This distribution of sensors enables the determination of AE sources (such as propagating flaws) in a specific 60° sector of the RPV. Based on a number of criteria, the AE sources and the areas where they are located are classified into three categories according to the Association Française des Ingénieurs en Appareils à Pression (AFIAP) best practices guideline for AE inspection of pressure vessels:
