SAFETY CASE 2015

Doel 3

Reactor Pressure Vessel Assessment

28 10 2015

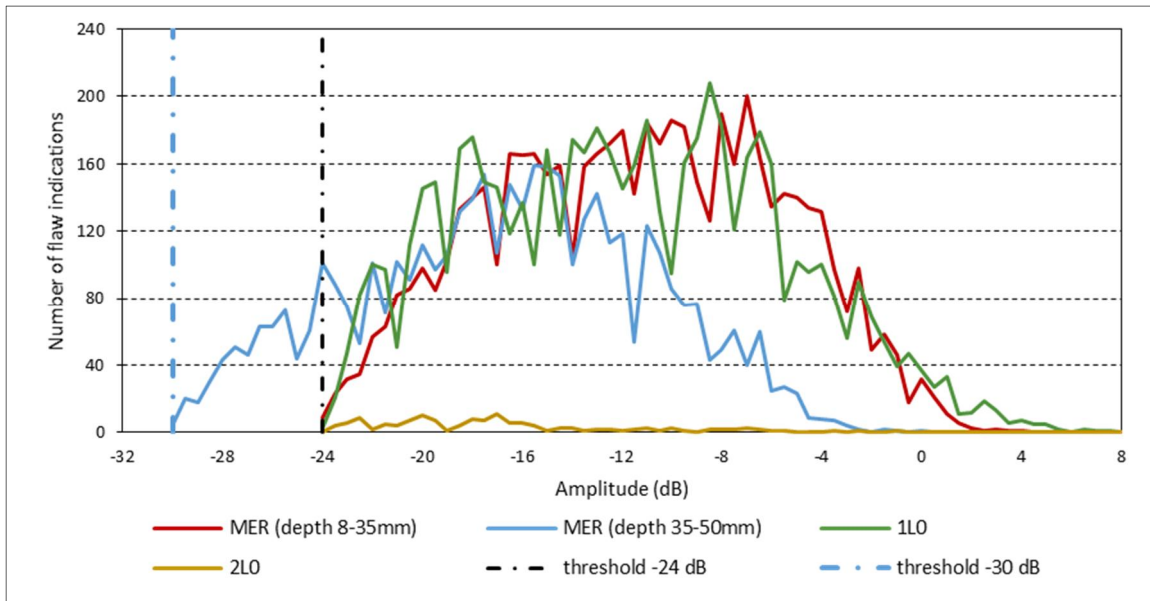
Figure 4.8: Indication amplitude distribution (4 shells).

The full detection capability is further demonstrated by the vanishing left end of the amplitude distribution of each transducer at its reporting threshold (Figure 4.8).

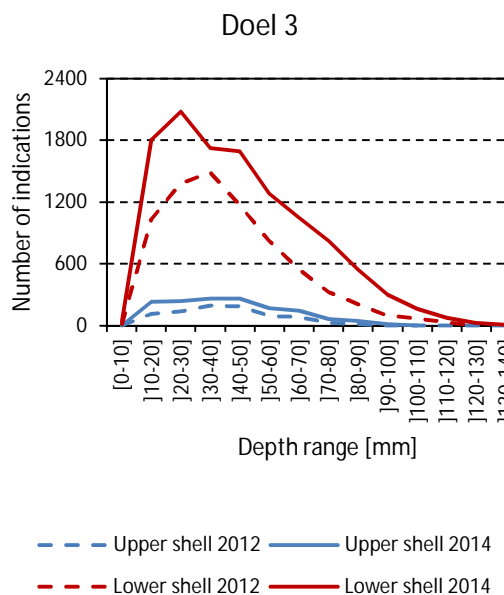
Figure 4.9: Depth distribution of the indications in the RPV shells.

The 2012 inspection showed that the indications are not spread over the entire volume of the RPV shells. The 2014 re-inspection confirmed that the indications are located in those parts of the shells that were already known to contain flakes during the 2012 inspection (Figure 4.9).

As more indications have been reported in the same zones of the RPV shells, the indication density has increased and the distance between the indications has decreased as compared to 2012. The conservativeness of the optimized sizing process tending to report indications larger than the actual flake size, even further decreases the measured distance between the indications.

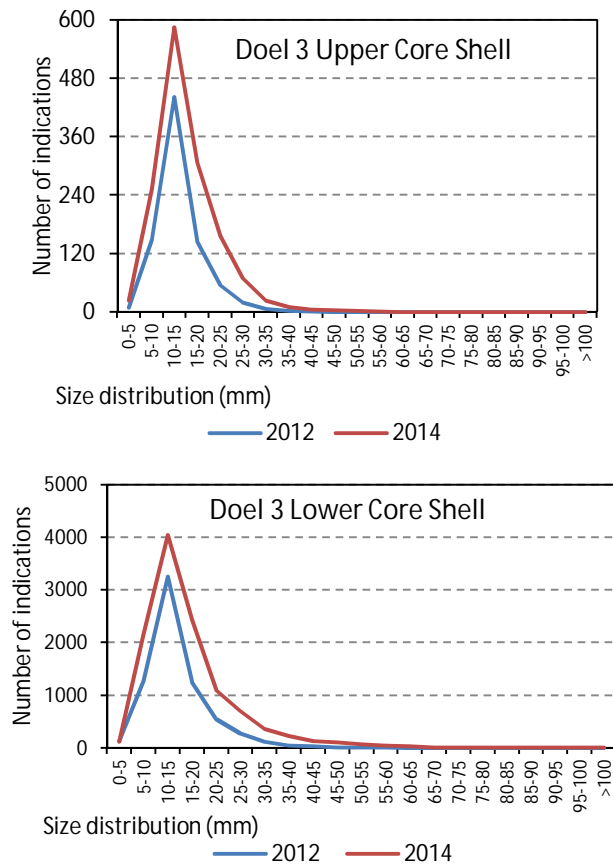
Figure 4.11: Indication size distribution in the Doel 3 RPV shells.

The maximum reported dimensions are much larger than what was reported in 2012. These large indications result from the non-discrimination of smaller clustered flakes using the optimized sizing procedure.

The re-inspection of the RPV shells revealed that the size distribution of the indications remained practically unchanged from 2012 to 2014 (Figure 4.11).

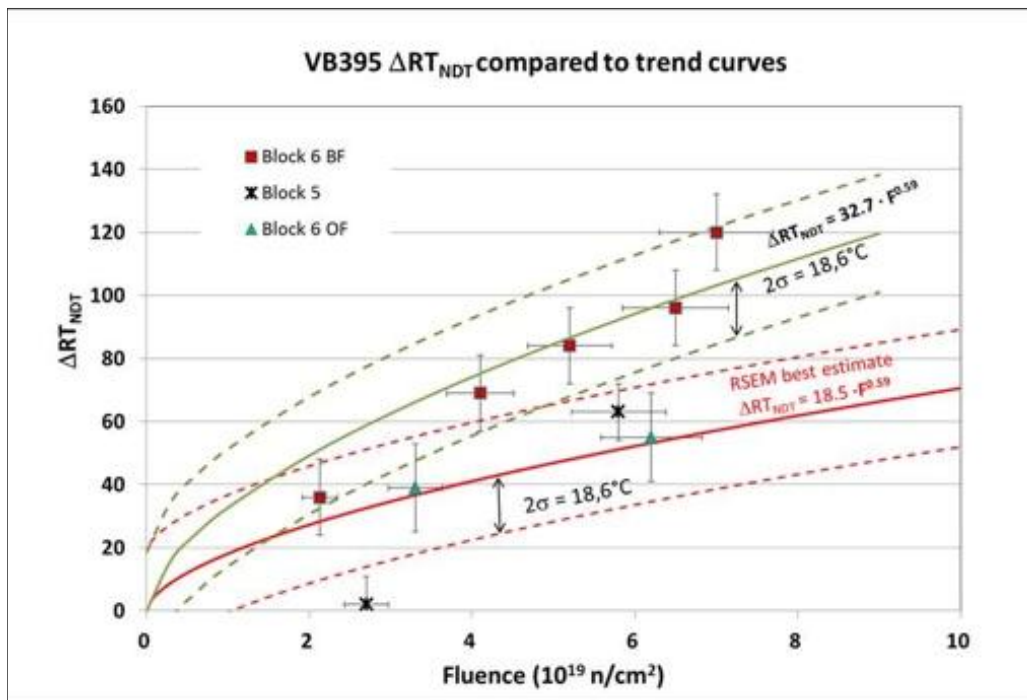
Figure 5.18: Measured shifts in RT_{NDT} for VB395.

- The T_0 shift is largely above predictions.
- The RT_{NDT} shift in specimens taken between flakes is above the trend curve predictions but to a lesser extent than the fracture toughness (Figure 5.18).

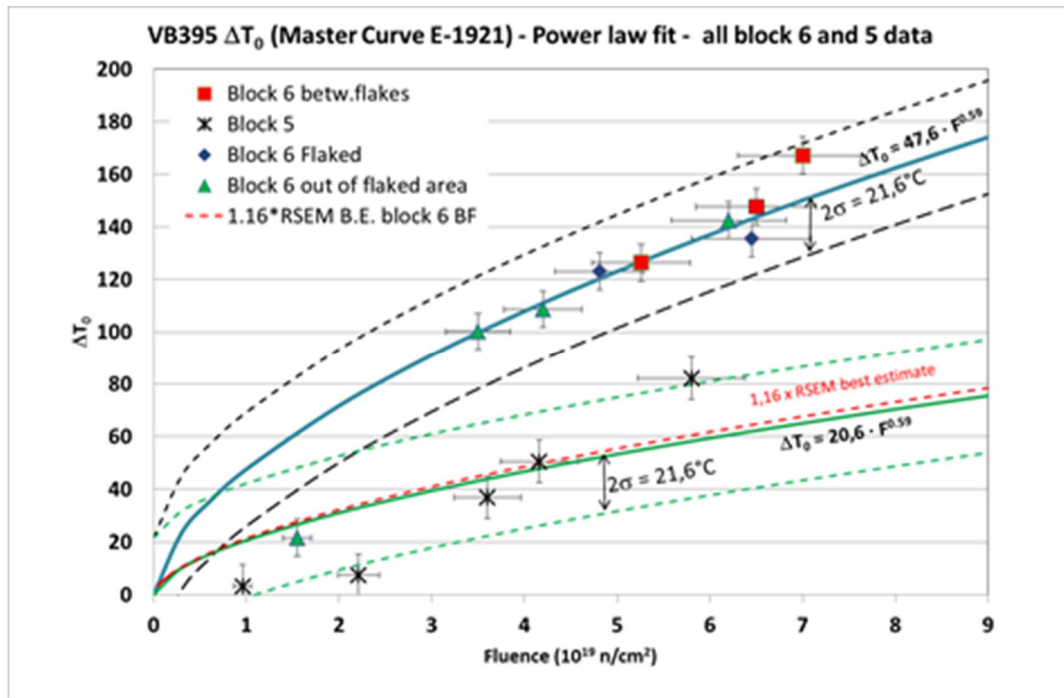
Figure 5.19: Measured shifts in T_0 for VB395.

- As shown in Figure 5.19, specimens between flakes and with flakes follow the same T_0 trend curve confirming the finding under non-irradiated conditions that the presence of hydrogen flakes does not cause a specific sensitivity to irradiation embrittlement. This observation is further confirmed through ductile fracture resistance tests performed on specimens taken between flakes and with flakes as crack initiator.

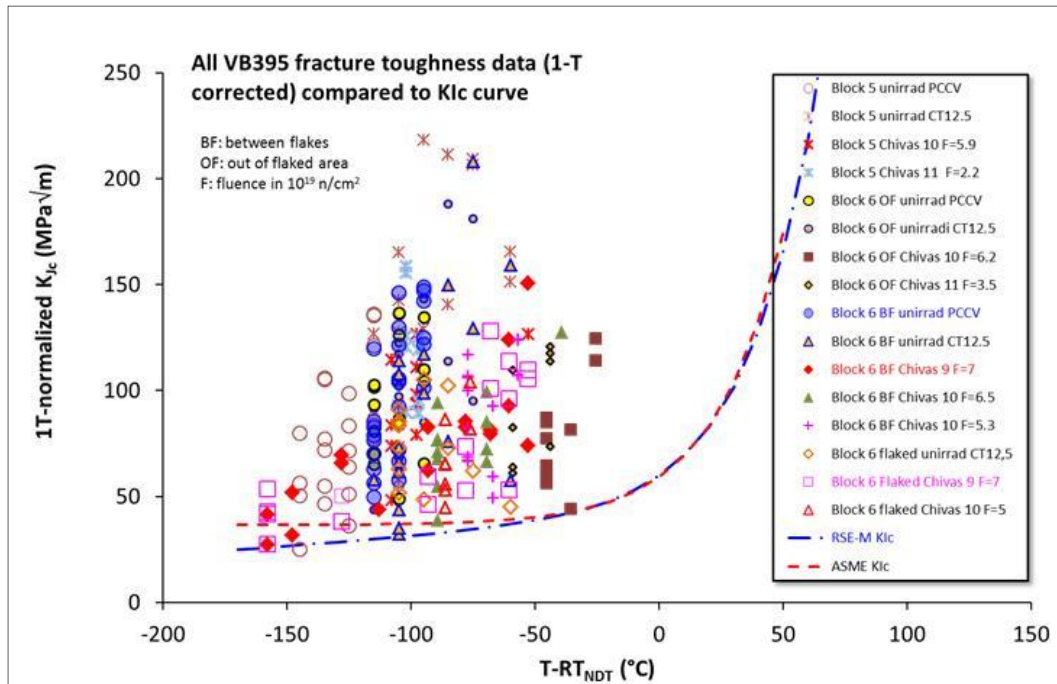
Figure 5.20: All fracture toughness results for VB395 materials compared to RSE-M and ASME K_{1c} curves.

- Nevertheless, all fracture toughness results for VB395 remain enveloped by the RSE-M (Ed. 2010) and ASME K_{Ic} curves indexed to $T-RT_{NDT}$, as shown in Figure 5.20.

- Although there is a high shift of the fracture toughness curve under irradiation, there is no indication of a decrease of the lower shelf of the fracture toughness curves.

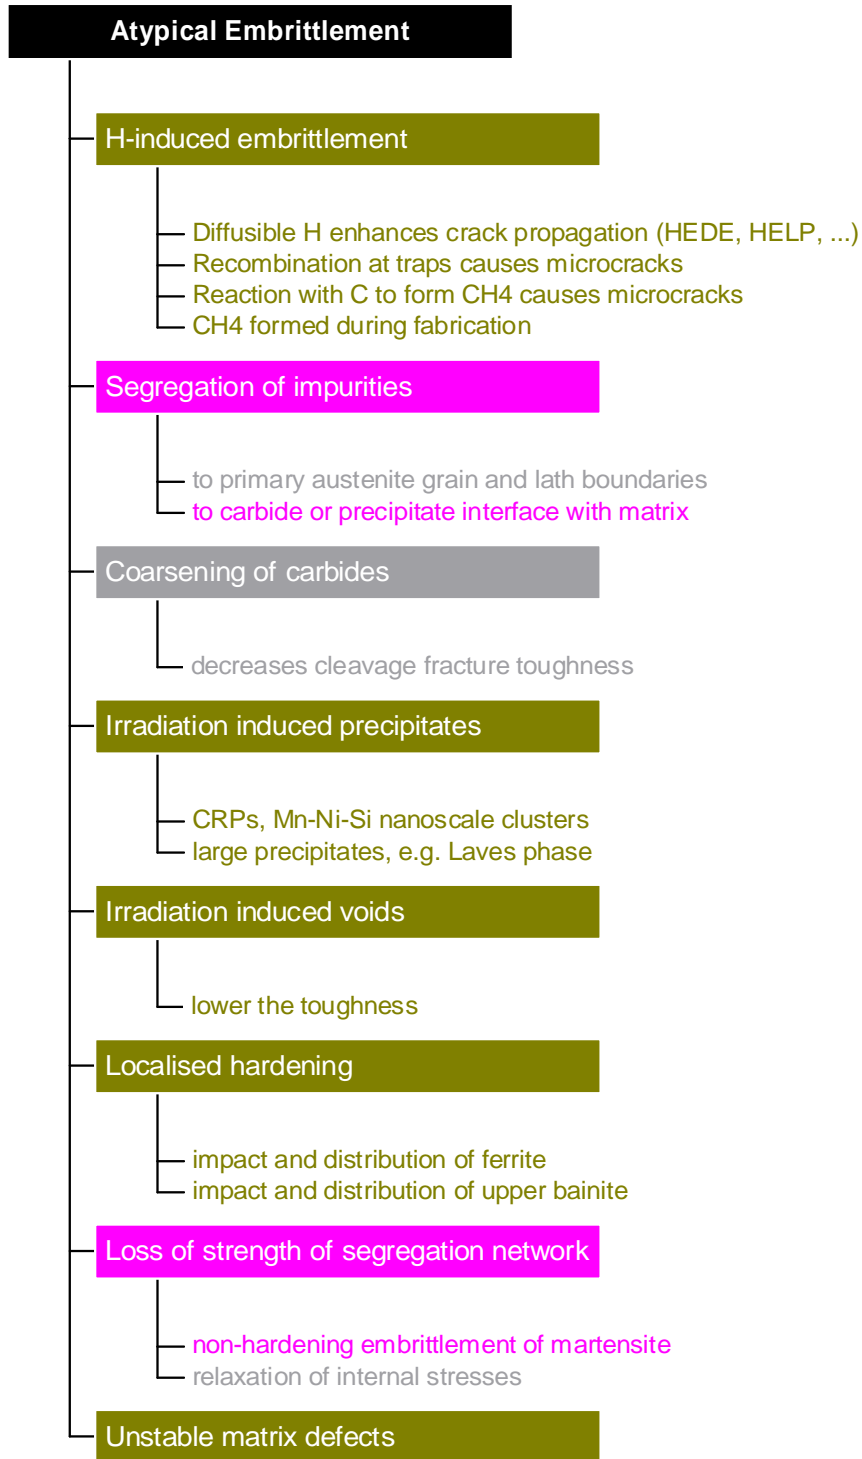
Figure 5.22: List of potential VB395 atypical embrittlement mechanisms after plausibility analysis.

All considered mechanisms have been qualified as excluded, unlikely or possible. The results are the following (Figure 5.22):

A strongly marked segregation network containing tempered martensite is present in VB395, whereas this network is much less visible and contains much less tempered martensite in D3T2. Literature shows that this type of microstructure is particularly sensitive to irradiation embrittlement due to enhanced diffusion of P in martensite. As shown above, VB395 could be susceptible to segregation of impurities.

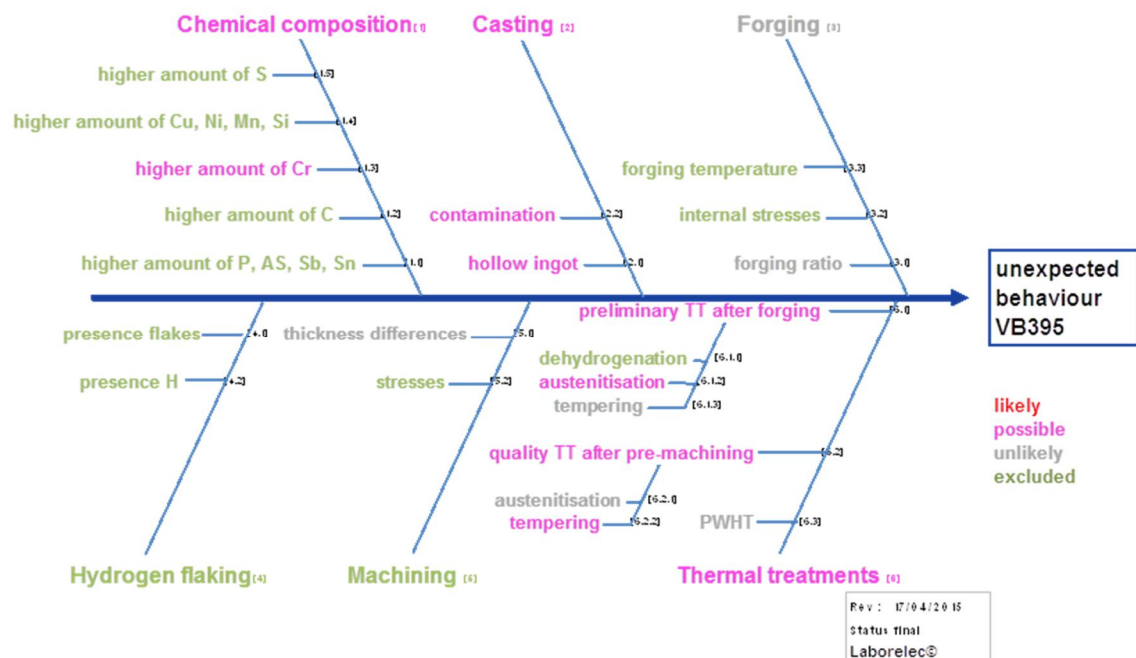
Figure 5.23: Fishbone diagram with colour-coded root causes.

Figure 5.23 shows the classification of the specific aspects of the manufacturing history of VB395 according to their plausibility. Possible root causes were identified in three domains: chemical composition, casting technique and thermal treatment. These causes can be linked with the possible mechanisms identified in the mechanistic approach:

- The higher amount of Cr of VB395, caused by contamination during the casting process, could have an influence on the P segregation and formation of carbides, as well as on the hardenability of the steel (contributing to a higher amount of tempered martensite). This is directly linked to both remaining possible mechanisms.
- The different casting procedure of VB395 can have an influence on the macro- and micro-segregations and the presence of a micro-segregation network. This is directly linked to the second remaining possible mechanism (loss of strength of segregation network).
- The deviating thermal treatments of VB395 can have an influence on the microstructure of the component (proportion of martensite, bainite, ferrite as well as formation, composition and coalescence of carbides). This is directly linked to both remaining possible mechanisms.

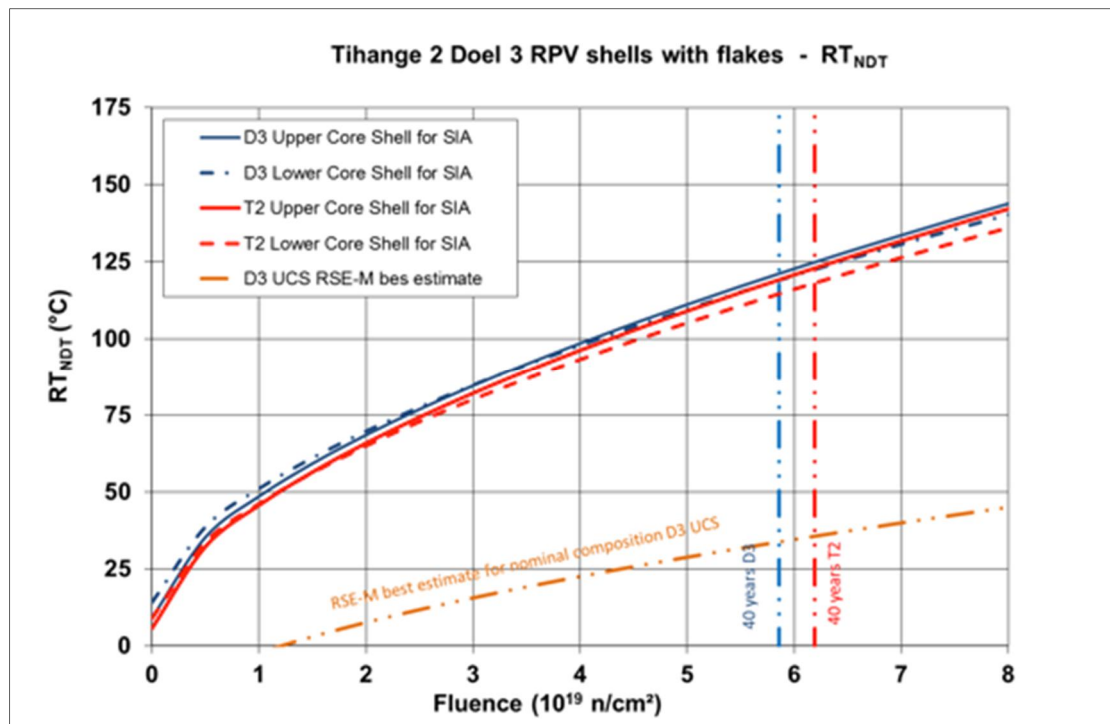
Figure 5.27: RT_{NDT} trend curves for the D3T2 core shells used in the SIA.

The final RT_{NDT} values to be considered for the four D3T2 core shells as a function of fluence are given in Figure 5.27. This figure also shows the expected maximum fluence values in the RPVs after 40 years of operation.

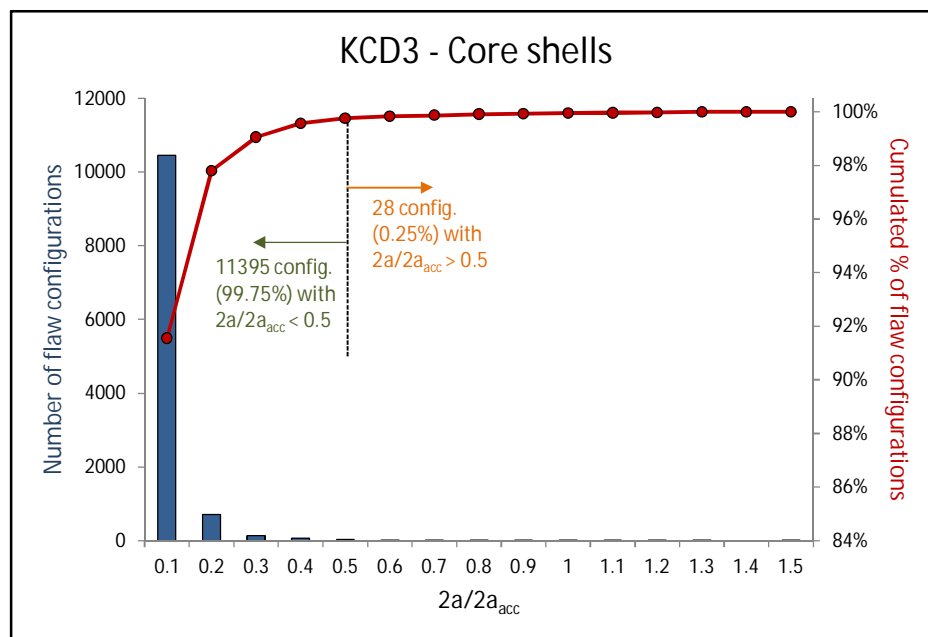
Figure 6.9: Flaw screening criterion applied to the core shells of Doel 3-Histogram.

The flaw configurations meeting this screening criterion are considered harmless. As shown in Figure 6.9, most of the flaw configurations meet this screening criterion.

The few remaining flaw configurations that did not meet the screening criterion were subjected to a more refined analysis.

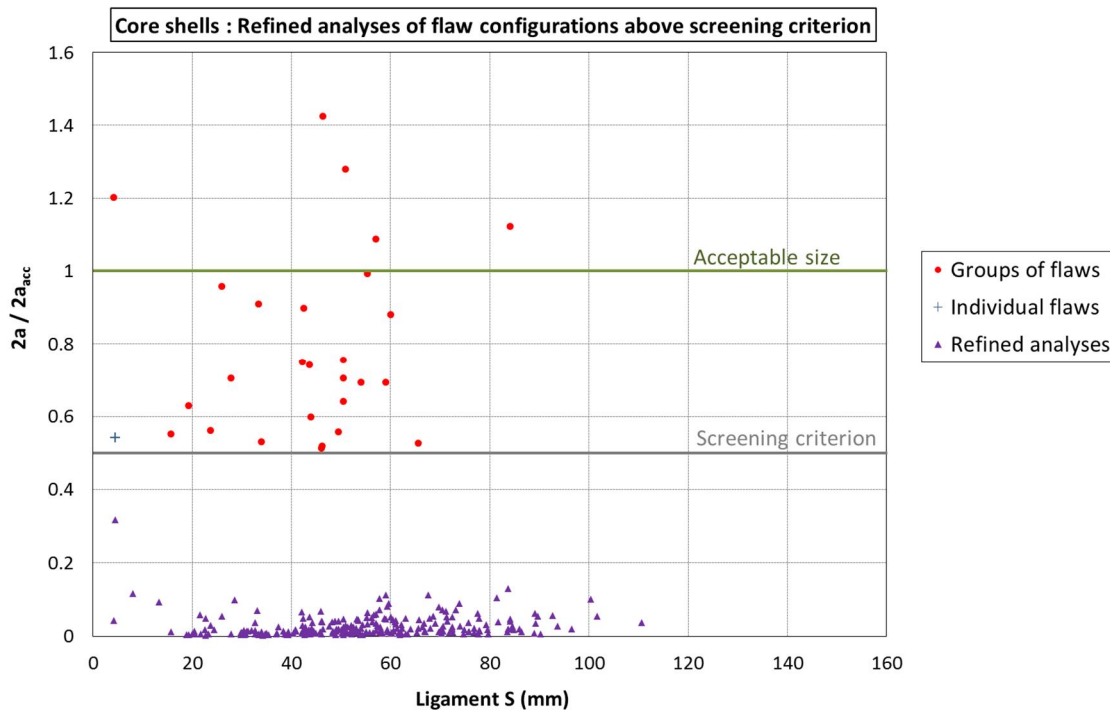
Figure 6.12: Comparison of core shell flaw configurations of Doel 3 to acceptable size as a function of ligament after 3D refined analyses.

All of the flaws that were considered in the refined analysis (i.e. the few flaw configurations not satisfying the screening criterion) meet the acceptance criterion with a considerable safety margin: maximum $2a/2a_{acc}$ ratio of 0.32 in the Doel 3 RPV (Figure 6.12).

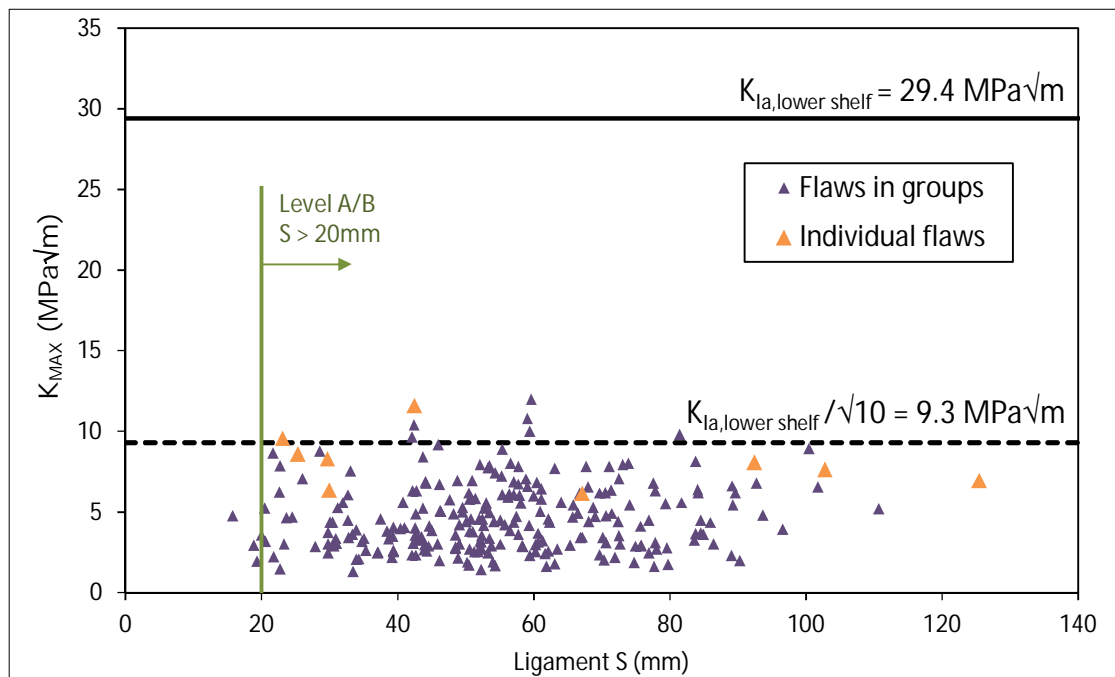
Figure 6.14: K_{MAX} values compared to lower shelf toughness for flaws far from the cladding-base metal interface (Doel 3 RPV).

The vast majority of the flaws have a K_{MAX} value below the $K_{IR,lower shelf}/SF$ which means that their acceptability is independent of the RT_{NDT} . For the Doel 3 RPV, there is only one flaw close to the cladding for which K_{MAX} exceeds $K_{Ic,lower shelf}/\sqrt{2}$ and 8 flaws far from the cladding for which K_{MAX} exceeds $K_{Ia,lower shelf}/\sqrt{10}$.

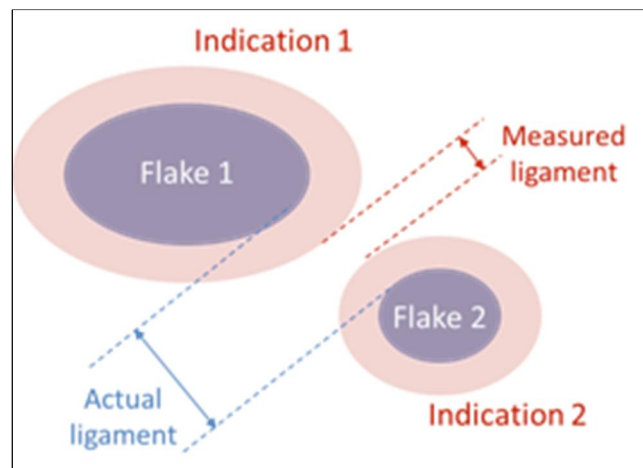
Figure 6.21: Undersizing the sound metal ligament between two oversized neighbouring flaws.

The overall tendency of the flaw sizing procedure is to overestimate actual flaw dimensions. This has been highlighted during the UT qualification exercise with flakes cut from block VB395/2A and subjected to detailed destructive examination (C1). Moreover, the size of small flakes is increased up to the beam size, before proceeding to structural integrity calculations (C2). Consequently, oversizing neighbouring flaws leads to undersize the sound metal distance between them (Figure 6.21), or, should the flaws lie too close to be possibly discriminated, to report them as a single large indication (C3).

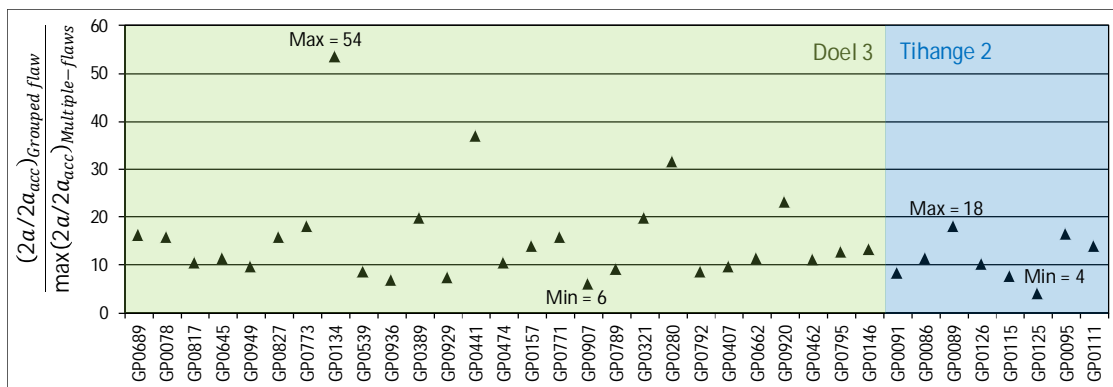
The conservativeness linked to the proximity rules (C9 and C10), to the grouped flaw definition (C11 and C12) and to the acceptable size calculation (C14) are together illustrated in Figure 6.24. This figure compares the ratio to acceptability before (grouped flaw) and after (multi-flaw) refined analysis.

For Doel 3, the ratio $2a/2a_{acc}$ of the grouped flaw is between 6 times and 54 times higher than the ratio $2a/2a_{acc}$ calculated with refined analyses.

Figure 6.24: Impact of multiple-flaws analyses on $2a/2a_{acc}$ for Doel 3 and Tihange 2 core shells.

On the other hand, the conservativeness linked to the characterization of individual flaws (C12) and to the acceptable size calculation (C14) are highlighted by the refined analysis of the highest $2a/2a_{acc}$ individual flaw, the ratio to acceptable size dropping from 0.54 to 0.32.

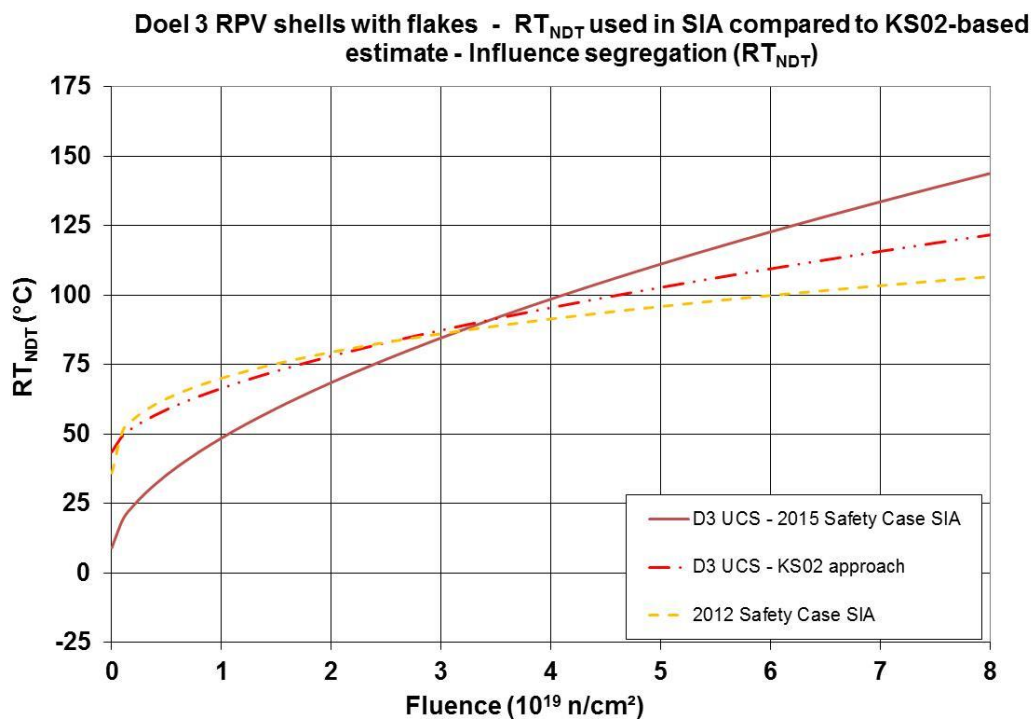
The fracture toughness curve used in the SIA is based on the conservative transfer of VB395's atypical embrittlement to the D3T2 RPV shells. A sensitivity study was performed to evaluate an alternative approach based on the German KS 02 material.

- In the D3T2 RPV forgings a large part of the segregated zone was removed by the piercing of the ingots. In the KS 02 component, no piercing was performed and hence the whole segregated zone is maintained.
- The difference of 47°C is read from the Charpy curves inside and outside the segregated zone at the 41J level. This difference cannot be interpreted as a difference in RT_{NDT} in unirradiated conditions as the latter is defined by a combination of Pellini drop weight and Charpy impact tests. For the KS 02 material, this leads to a difference in RT_{NDT} in unirradiated conditions of only 3°C instead of 47°C.

The curve of RT_{NDT} evolution vs. fluence for the KS 02-based approach for the upper core shell of Doel 3 is compared in Figure 7.1 to the curve used in the SIAs in 2014-2015 as well as to the curve used in the initial Safety Case of 2012. The KS 02-based approach is close to the one of the 2012 Safety Case in the fluence range of interest (up to $6 \cdot 10^{19} \text{ n/cm}^2$). It is more conservative than the VB395-based approach in the low fluence range (up to approximately $3.4 \cdot 10^{19} \text{ n/cm}^2$) and less conservative above this value.

Figure 7.1: RT_{NDT} evolution with fluence considered in the 2014-2015 SIA compared to the curve of the initial Safety Case and to the alternative KS 02 based approach.
